APPENDIX 2

Condition reports

Object Title: Sherborne Abbey previous West window Panel 2d	
Recorded by: A Gilchrist	Date: 25/06/2010
Location: Kings Manor Workshop University of York	Photographs:

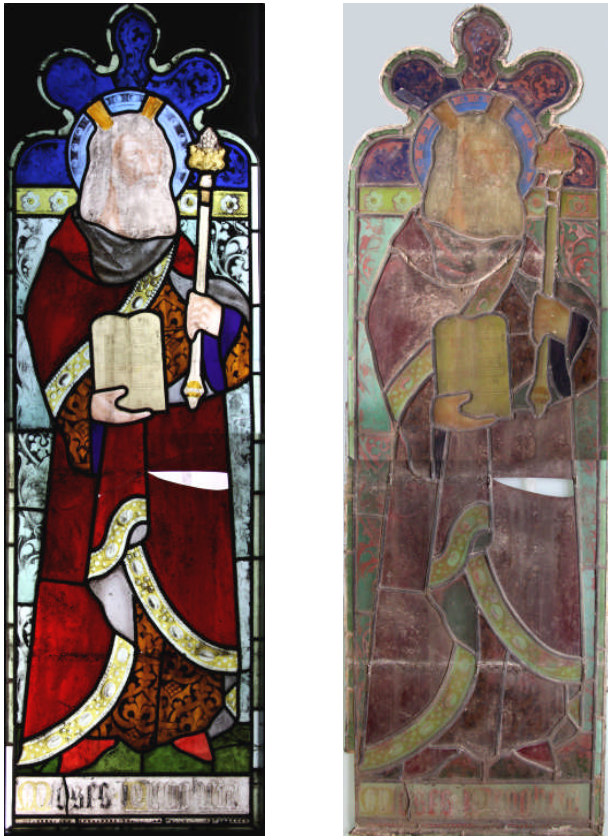
Owner / client: London Stained Glass Repository	
Iconography: Figure of Moses holding tablets with the 10 Commandments	
Inscription: Moses Propheta	
Dimensions (h x w in mm): 1625 x 510	
Materials and condition:	
Glass: White, yellow, green and blue tinted glasses; light and dark blue, yellow and green potmetal glasses; ruby flashed glass. ca. 12 cracked pieces; 1 missing area of red trapery; 1 border piece missing (bottom of left hand side). Otherwise, good condition; no evidence of glass corrosion or other deterioration.

Dark brown glass paint, very reddish in reflected light; traceline detail generally on inside with significant use of backpainting on reverse side; yellow silver stain on reverse; carnation flesh tone on reverse (head and hands). Severe paint loss throughout; remaining paint surface appears powdery / crumbly. Heavy dirt deposition on both sides. Yellow potmetal pieces reversed with paint on outside, much better preserved, as is backpainting.

6 mm flat internal leads, 10 mm flat perimeter leads. One 3 mm mending lead, probably original to panel. Bottom perimeter lead is missing. Several poor and/or broken solder joints. Much lead corrosion evident, especially of perimeter leads.

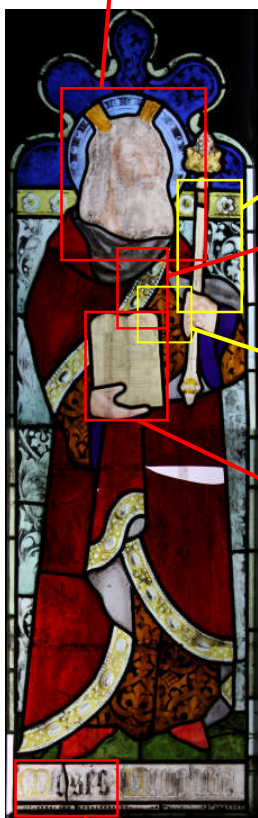
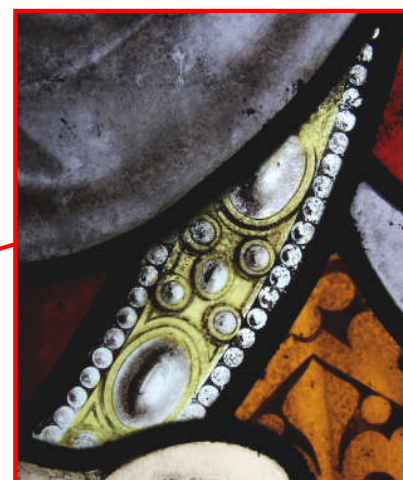
Surviving background detail

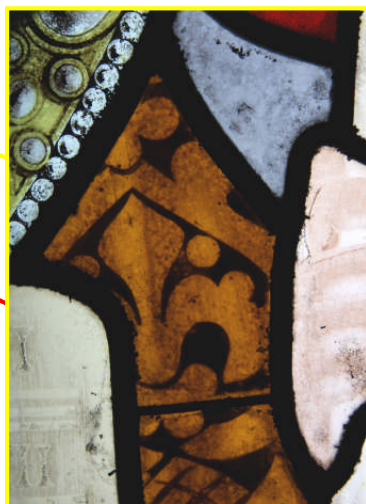
Surviving decorative detail with yellow stain

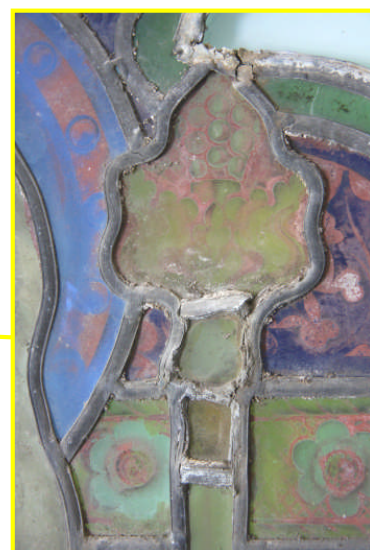
Deteriorated surface of surviving paint

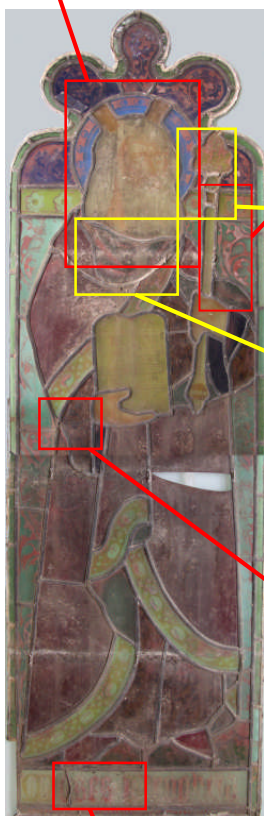
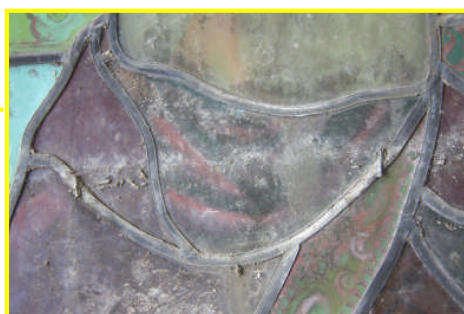
Previous repair: inserted stopgaps

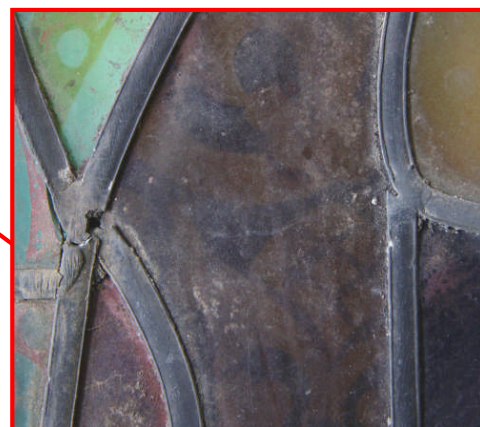
Surface dirt, remains of copper ties

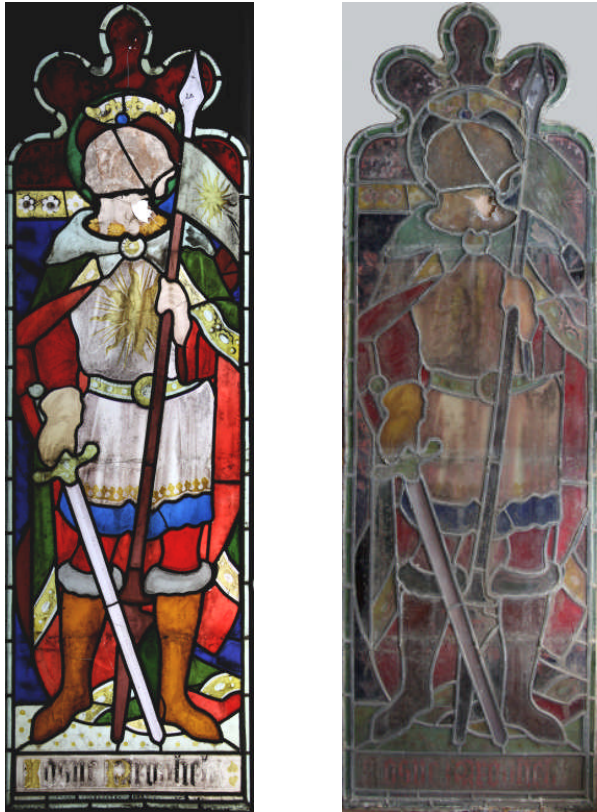
<i>transmitted light</i> <i>reflected light</i>
Owner / client: London Stained Glass Repository	
Iconography: Figure of Joshua	
Inscriptions: Iosur Propheta	
Dimensions (h x w in mm): 1620 x 510	
Materials and condition:	
Glass: White, yellow, green and blue tinted glasses; blue, yellow and green potmetal glasses; ruby flashed glass. 2 pieces with impact fractures leaving central holes and emanating cracks; ca. 11 other cracked pieces. Otherwise, good condition; no evidence of glass corrosion or other deterioration.	
Paint Layers: Dark brown glass paint, very reddish in reflected light; traceline detail on inside with significant use of backpainting for drapery etc on reverse side; yellow silver stain on reverse; carnation flesh tone on reverse (head and hands). Severe paint loss throughout; remaining paint surface appears powdery / crumbly (although backpainting rather better preserved). Heavy dirt deposition on both sides.

6 mm flat internal leads, 10 mm flat perimeter leads. Several 3 mm mending leads, probably original. Several poor and/or broken solder joints; evidence of lead corrosion, especially on perimeter lead.

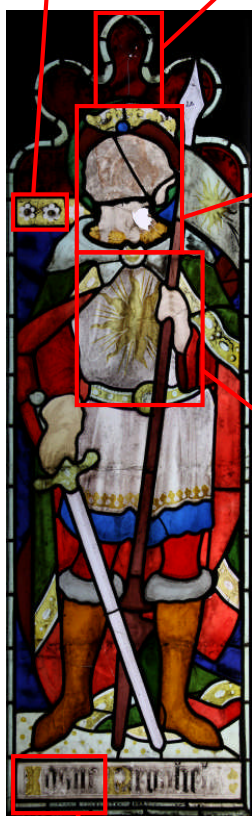
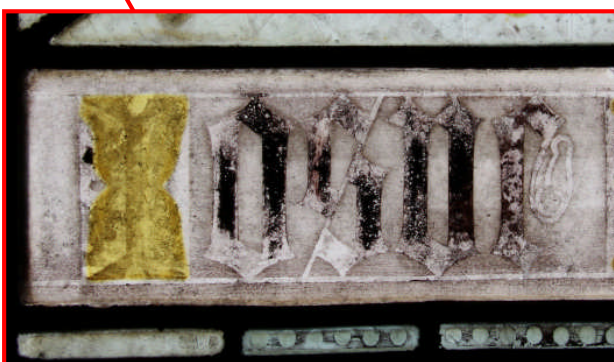
Paint loss from head; damage to inserted piece

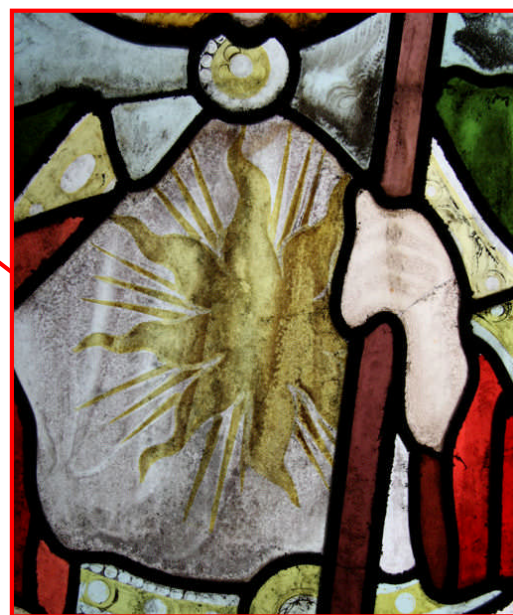
Paint loss from inscription

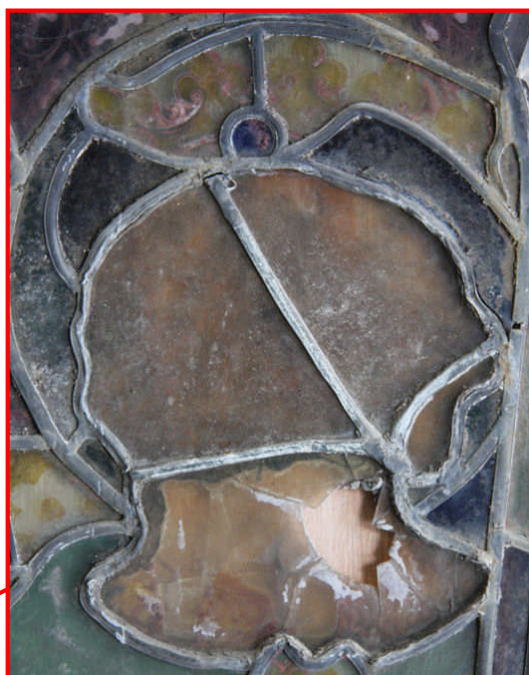
Damage and previous repair to head

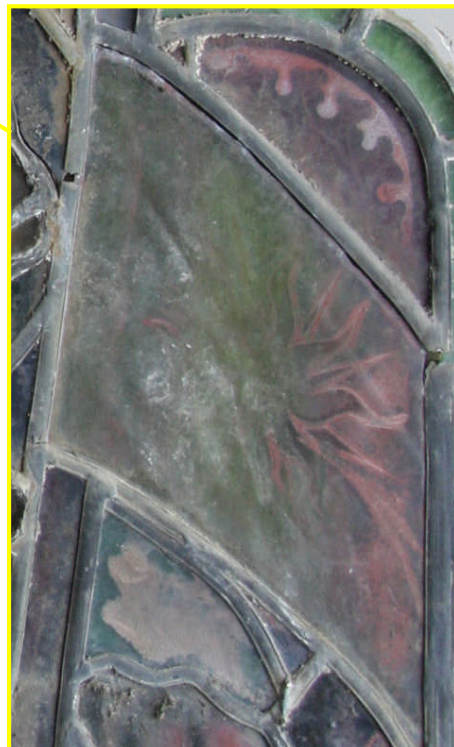
Surface dirt and some surviving paint

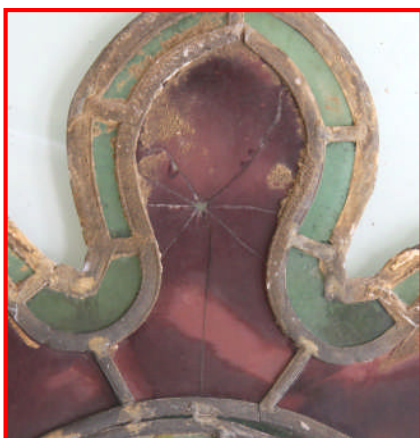
Impact fracture; putty remains; surviving back-painting

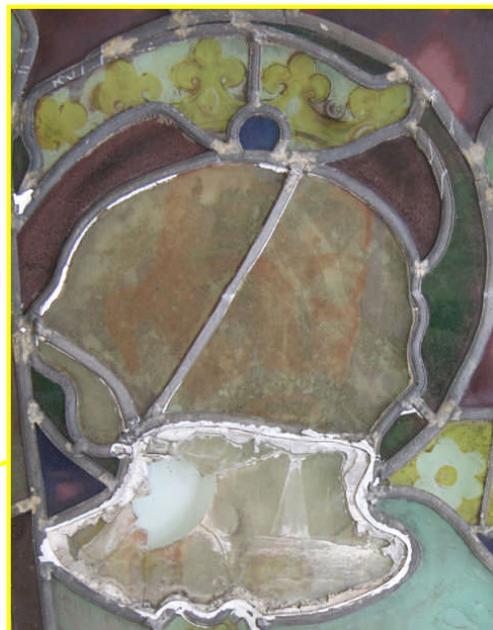
Previous repair insertion to head

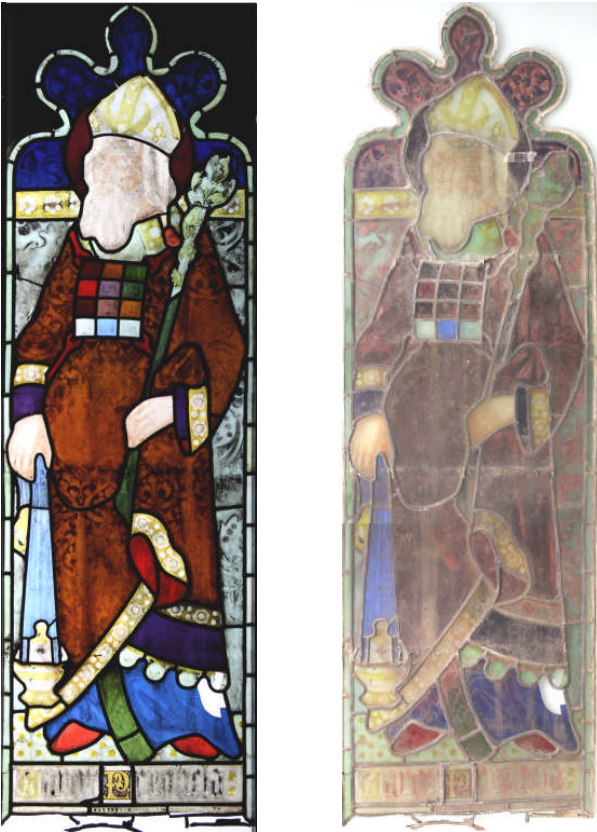
<p style="text-align: center;"><i>transmitted light</i> <i>reflected light</i></p>
Owner / client: London Stained Glass Repository	
Iconography: Figure of Aaron with censer and flowering rod	
Inscriptions: Aaron Propheta	
Dimensions (h x w in mm): 1620 x 510	
Materials and condition:	
Glass: White, green and blue tinted glasses; light and dark blue, yellow and green potmetal glasses; ruby flashed glass. 3 pieces with impact fractures leaving central holes and emanating cracks; ca. 9 other cracked pieces. Bottom border glass missing. Otherwise, good condition; no evidence of glass corrosion or other deterioration.

Dark brown glass paint, very reddish in reflected light; traceline detail generally on inside face, with significant use of backpainting on reverse side; yellow silver stain on reverse; carnation flesh tone on reverse (head and hands). Yellow potmetal pieces are reversed, i.e. traceline detail on outside and backpainting on inside. Severe paint loss throughout; remaining paint surface appears powdery / crumbly except paint on outside of yellow pieces much better preserved (visible areas of deterioration caused by water running down panel). Heavy dirt deposition on both sides.

6 mm flat and 4 mm round internal leads, 10 mm flat perimeter leads. Several 3 mm mending lead, probably original. Several poor and/or broken solder joints and lead fractures; evidence of lead corrosion, especially on perimeter leads.

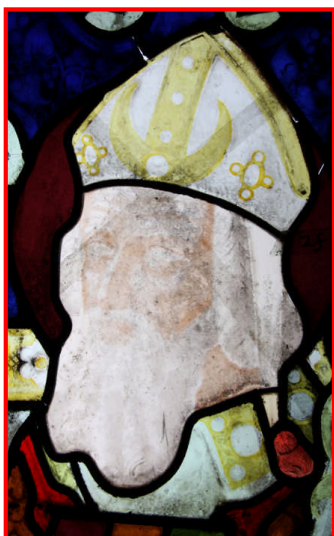
Paint loss, surviving yellow stain

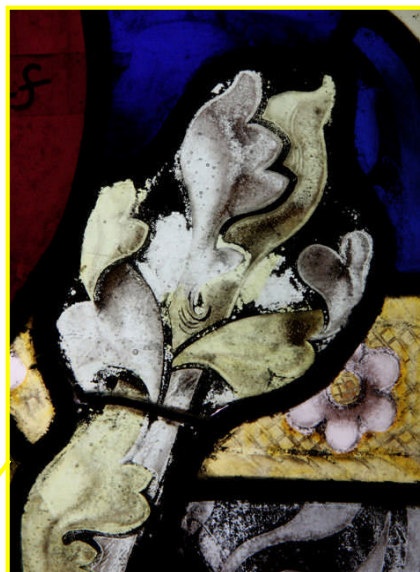
Paint loss, surviving yellow stain

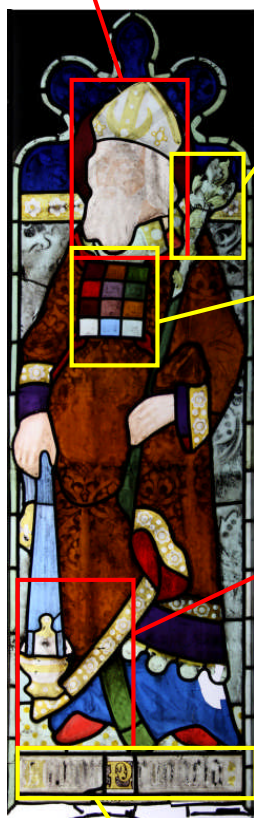
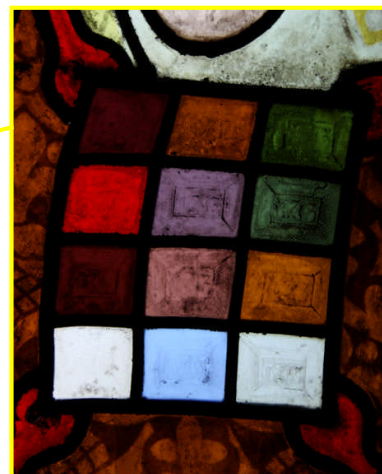
Paint loss

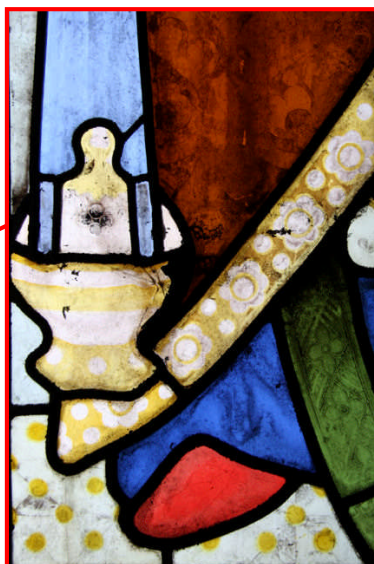
Paint loss, surviving yellow stain

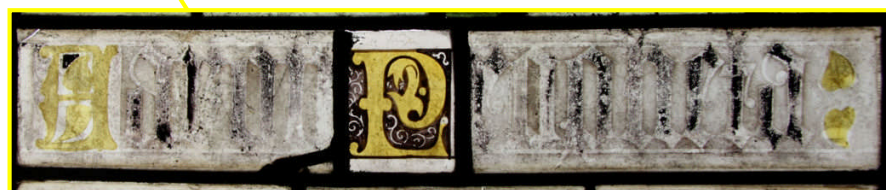
Paint loss, inserted repair piece

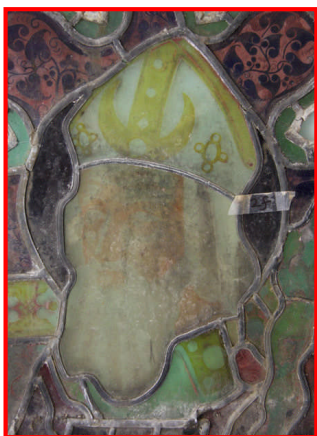
Paint loss

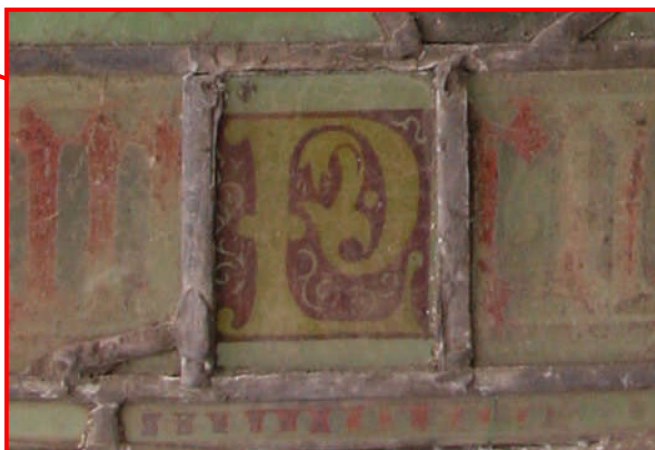
Inserted repair piece

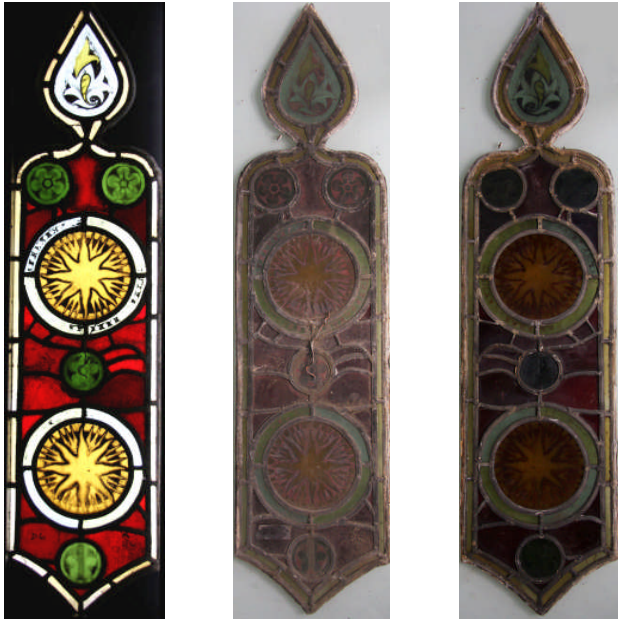
<p><i>transmitted light</i> <i>reflected light</i> <i>reverse face, reflected light</i></p>	
Iconography: Decorative		
Inscriptions: None		
Dimensions (h x w in mm): Each 845 x 210 mm		
Materials and condition:		
Glass:		
<p>Yellow, green, blue tinted glasses; pot metal green and blue glasses; ruby flashed glass.</p> <p>Occasional cracks (especially in neck area); heavy surface dirt and cobwebs with possible microbial infestation. Some patina (possibly surviving glass paint) on external face; otherwise good condition.</p>		
Paint Layers:		
<p>Brown glass paint, very reddish in reflected light. Detail tracelines on front face, with occasional use of backpainting (especially on red pieces, perhaps to dull appearance?). Severe paint loss throughout; remaining paint has crumbly / powdery appearance.</p>

6 mm flat and 4 mm round internal leads; 10 mm flat perimeter lead. Generally good condition. Several fractured solder joints; several missed solder joints, especially on external face.

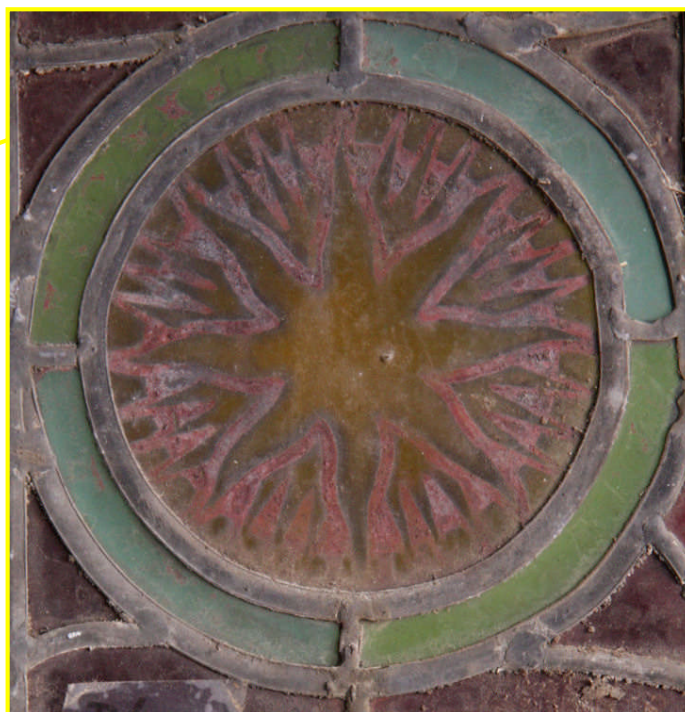
Surviving paint in poor condition

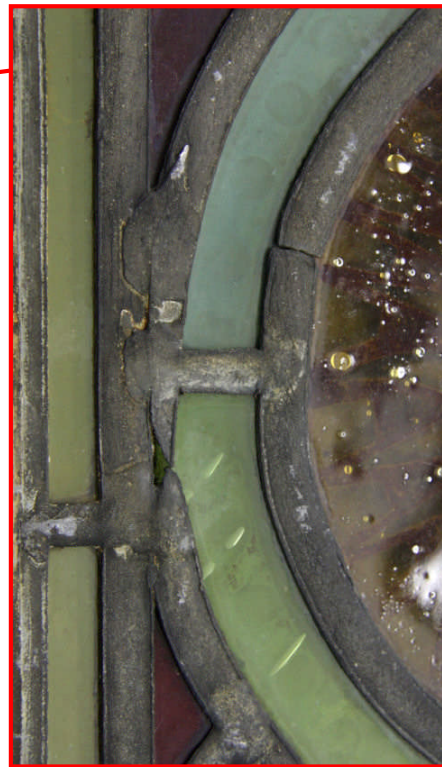
Poor / missing solder joints

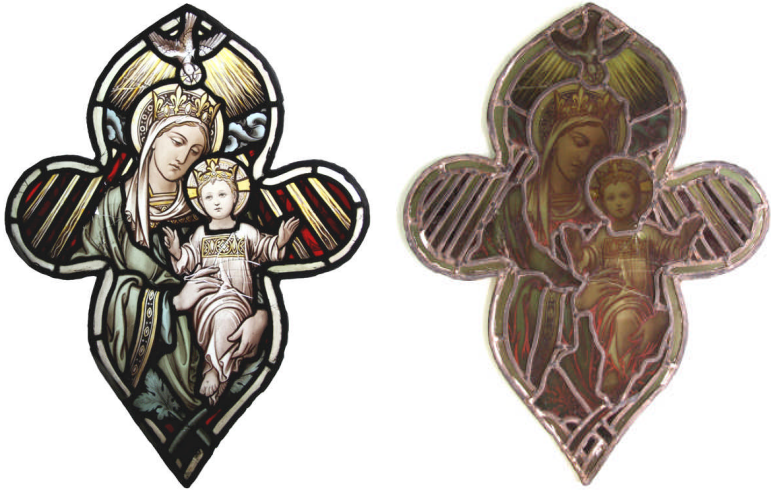
<i>transmitted light</i> <i>reflected light</i>
Owner / client: Daryl Buttery	
Iconography: Virgin and Child Top tracery panel from 'Tree of Jesse'	
Inscriptions: None	Dimensions (h x w in mm): 680 x 515 mm
Provenance and date: Top tracery panel from north transept window nVII (Tree of Jesse). All Saints Church, Emscote, Warwick (demolished 1967/8). Hardman and Co. Birmingham, 1889.	
Materials and condition:	
Glass: Several green tints and white, blue potmetal and ruby flashed antique glass. No sign of corrosion or other glass deterioration. 12 broken pieces. Surface dirt. Several splashes of white paint at edges presumably from surrounding walls.

Some evidence of paint loss / movement down the panel – appears redder towards lower areas of each piece. Rather powdery surface evident under microscope, some areas showing paint loss / holes.

5 mm flat lead with 10 mm flat lead on perimeter. Good condition, with some buckling at edges due to removal of panel. Remains of solder flux around all joints. One missed joint on front face.

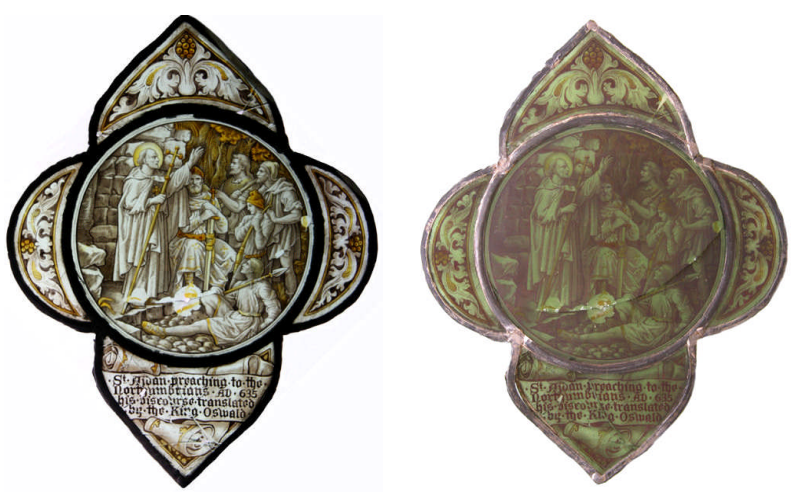
Upper lobe cracked at both corners; central roundel 2 cracks from impact with a large area of glass and paint shelled away; lower lobe (with inscription) badly cracked into many pieces with one small area missing.

Paint appears stable and well fixed; examination under microscope shows occasionally bubbly surface with some bubbles burst leaving pinholes – possibly slightly overfired.

8 mm flat lead throughout, in good condition. Some buckling due to panel removal; one broken solder joint.

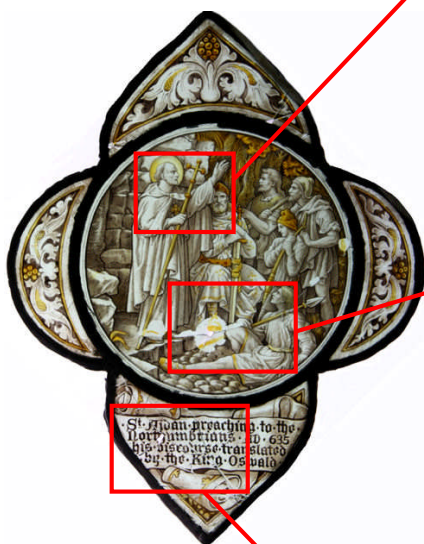
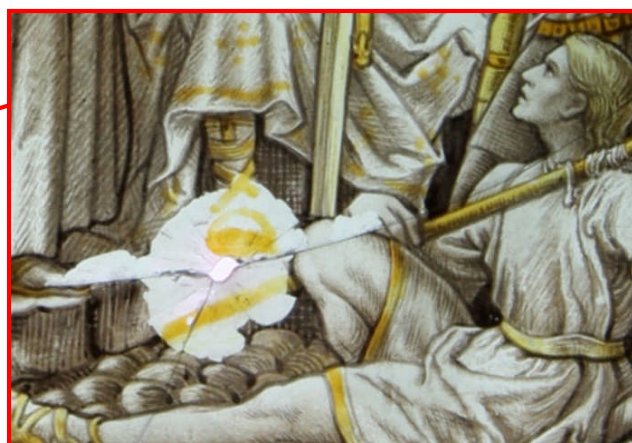
Impact fracture and shelled glass

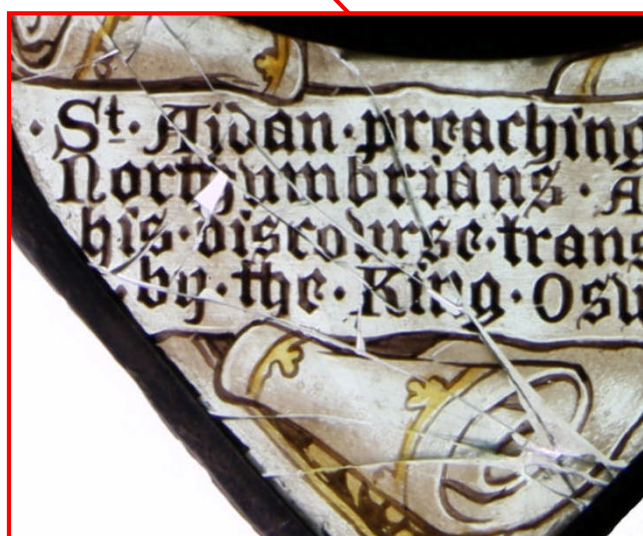
Badly broken inscription with small piece missing

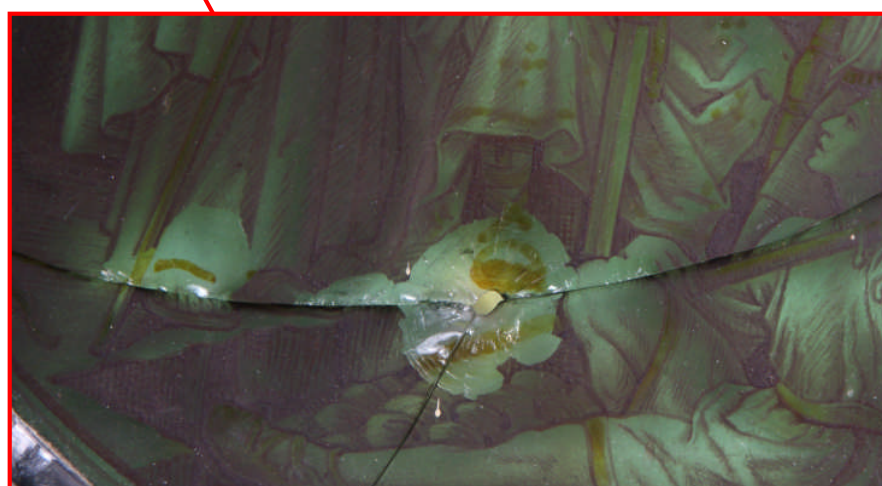
Impact fracture and shelled glass
