A History of Repairs to the Stained Glass in the Great East Window of Gloucester Cathedral

Léonie Seliger

MA in Conservation Studies (Buildings)
IoAAS

University of York
5 September 2001

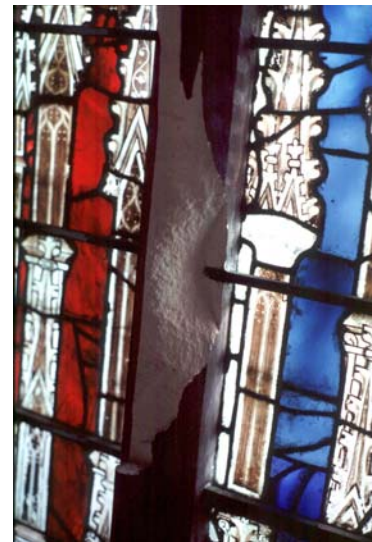
By 1934 the damage done by iron tie-bars and saddle-bars had become obvious in the choir clerestory windows, and new delta metal bars were installed (ibid. 1934).

fig. 10 Damage to mullion by expanding ferrous saddle bar.

Urgent repair of the stone and replacement of the iron components with phosphor bronze was needed. Three mullions had to be replaced entirely, as there was an immediate risk of more stonework falling. Smaller stone replacements, piecing and mortar repairs were necessary all over the window.

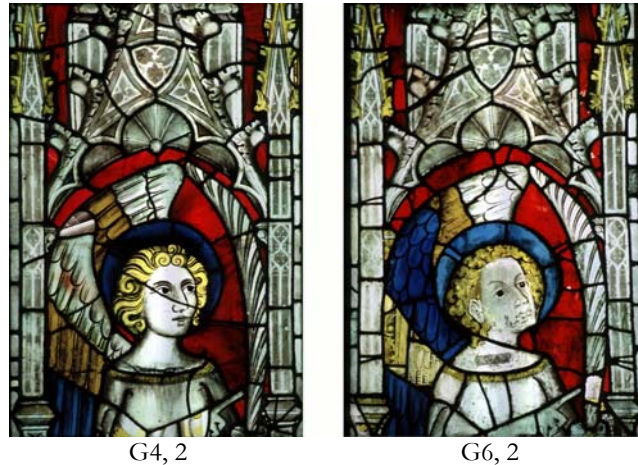
There is, however, one clear example of medieval repair still in existence: the head of the angel in G6 dates stylistically from the late fourteenth or early fifteenth century³. The outline of this head is identical to that of another angel (G4), which is a repeat of G6.

fig. 11 Medieval replacement head in contemporary style.
An example for the use of repeat cartoons.

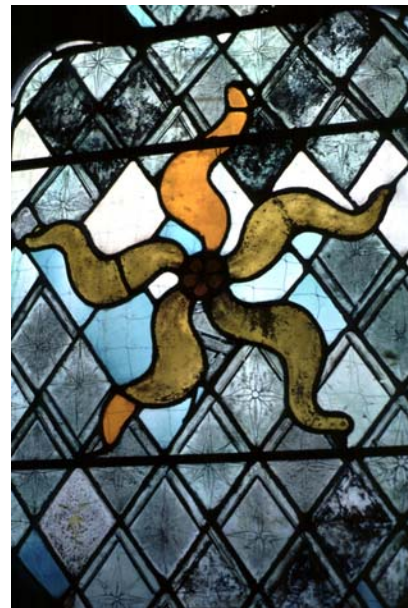
How many - if any - repairs were done by insertion of unpainted white glass in the figurative portion of the window is unclear. A few such repairs survive in the Great East Window (e.g. the 'Golfer's' head in C11), but they may have been part of an earlier or later repair campaign.

fig. 14 J3
Quarries replaced with unpainted glass

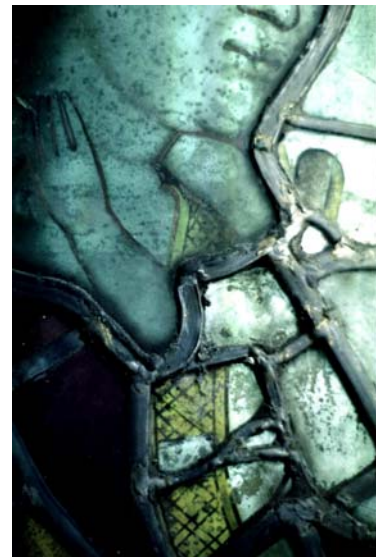
This same lead occurs in several other areas along the daylight borders and in corners of panels. In E11, 1 it was also used around the main outline of the figure, suggesting that this panel was partly dismantled.

fig. 19 Flat lead in G5

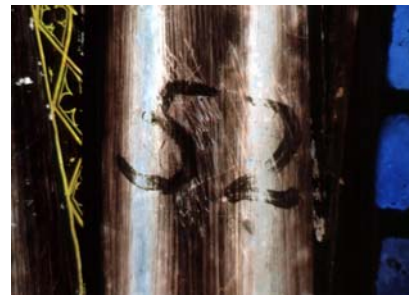
It was probably then that the panels were marked with numbers painted onto the glass. The paint used has adhered so well that it is still in situ. In a few places an attempt was made to remove it, but this has resulted only in scratching the glass paint.

fig. 21 Scratch marks in glass paint

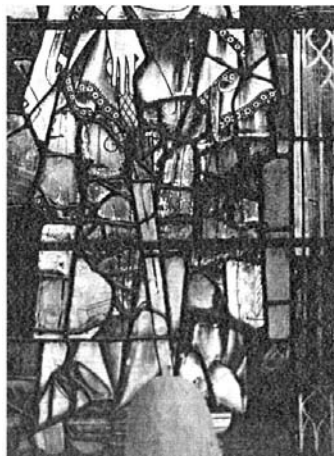
Pitcher's photo of 1913 shows that E7, 1 was very fragmented and seemed to contain a lot of corroded original glass and some alien fragments in the

fig. 22 E7, 1; 1913

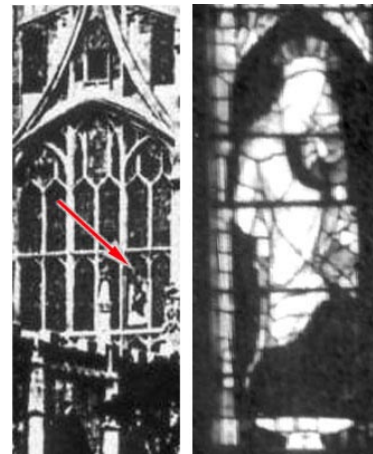
fig. 24 Exterior and interior views of G5 before 1976

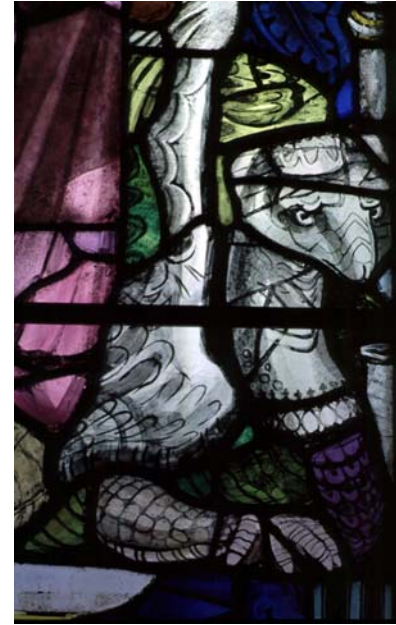
The weight of the plates and of the wide thick lead also caused the panels to buckle (a problem often associated with Whall’s stained glass), and consequently put the thin original glass under pressure.

fig. 26 Payne’s serpent

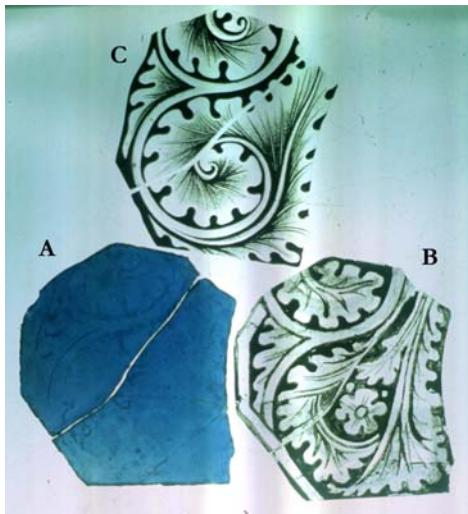
Payne's interpretation of the background decoration was idiosyncratic, but not very accurate. Having taken rubbings of the individual blue pieces, I discovered that it was possible to reconstruct the original pattern with a much higher degree of accuracy. This harmonised much better with the elegance of the surviving fifteenth century surface decoration.

fig. 27 old and new plating

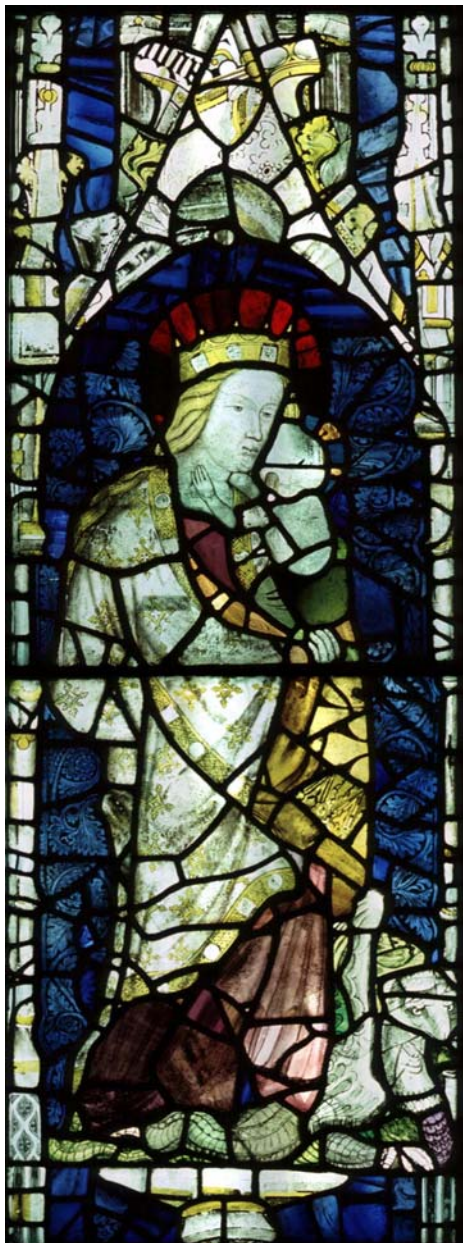
fig. 28 G5, 1& 2
Before restoration.

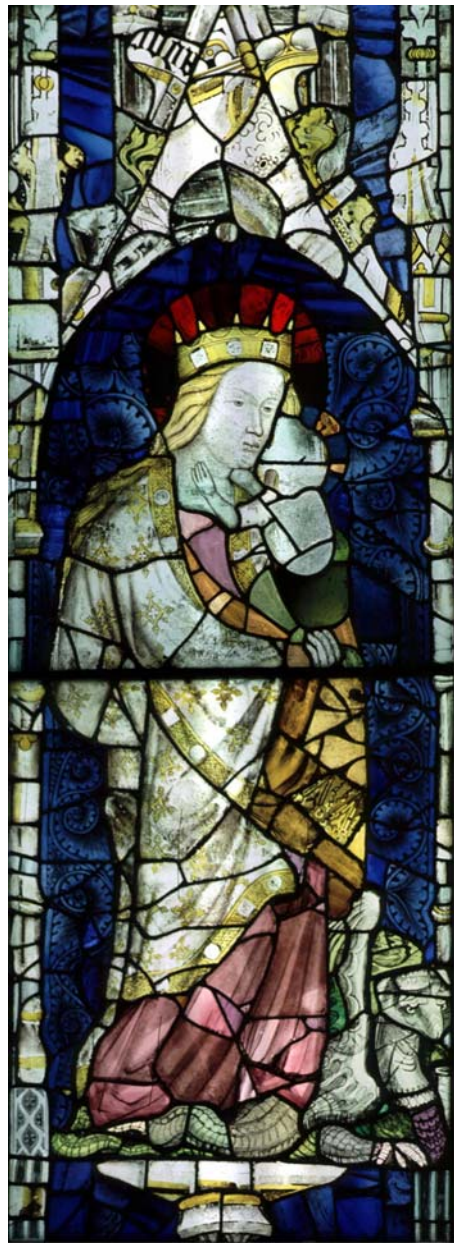
fig. 29 G5, 1& 2
After restoration.

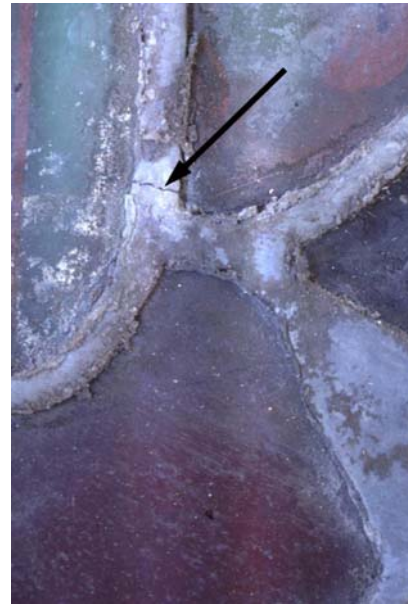
Assessments of the remaining twenty-four panels revealed that much of the leadwork, though generally stable, had developed hairline cracks, particularly near solder joints. Such fractures would not be cause for great alarm in panels that are in situ, are firm and well cemented and show little signs of bulging. While the state of such lead should be monitored, action is not necessarily needed.

fig. 30 Hairline fracture in lead next to solder joint

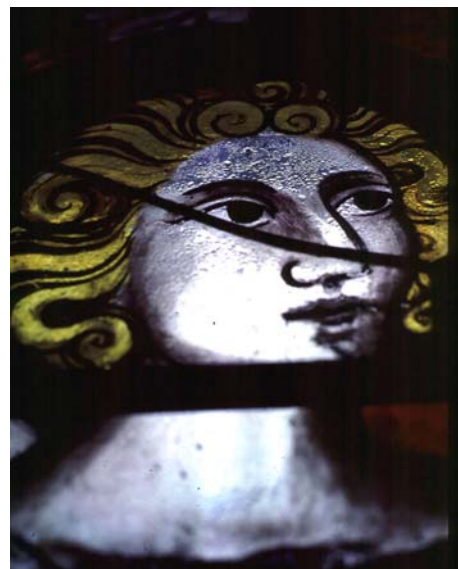
The Great East Window suffers from a high rate of condensation. This condensation occurs throughout most of the year, but is obviously worst during the winter months. The cathedral has been heated since the nineteenth century. Currently, two large heaters are situated directly below the north and south bays of the window, blasting hot air up the internal surface of the glass.

fig. 31 G4
Condensation on the internal surface of the
Great East Window

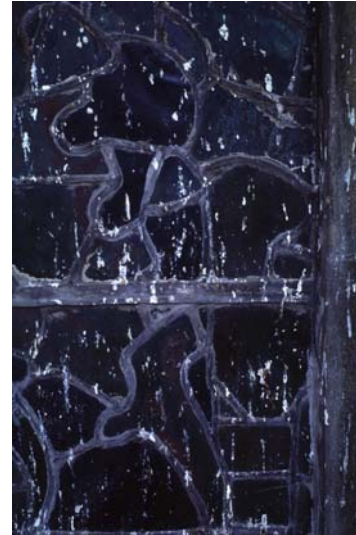
fig. 34 Pigeon guano on the exterior.

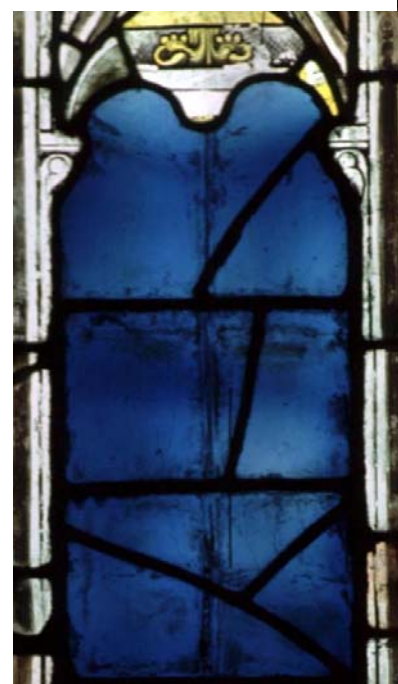
fig. 35 H3, 1
Corrosion line due to water run-off

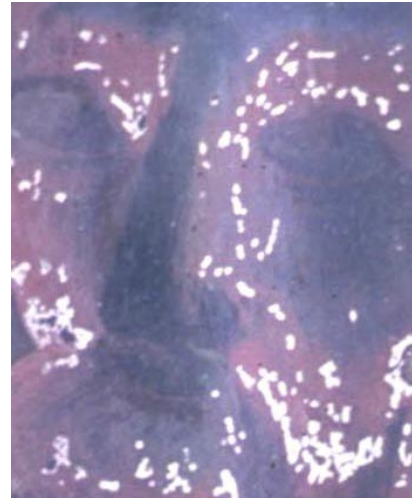
fig. 36 F3
Pitting on areas with back-painting

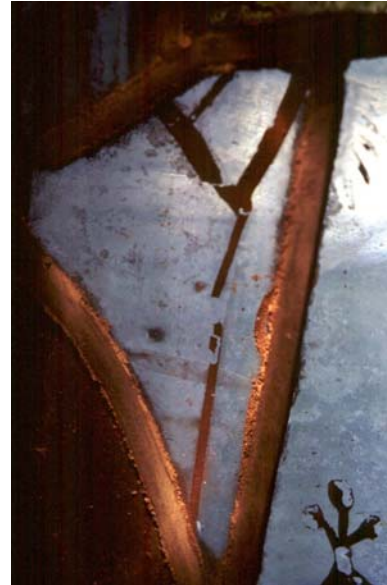
Much of the painted decoration is in stable condition, although some paint loss has occurred in the past. These paint losses affect both trace lines and smear shading. The thicker paint of the trace lines has in places flaked off completely, leaving only a faint ghosting on the glass surface. In some places loose flakes of paint have become completely dislocated, and are adhering to the glass surface by virtue of the grimy dirt which covers much of the glass. Many of the fifteenth century stopgaps are particularly badly affected.

fig. 37 Dislocated paint flakes.

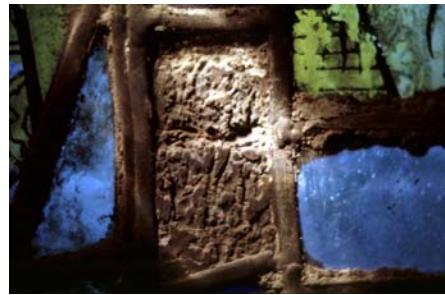
fig. 38 E13
Sugared glass

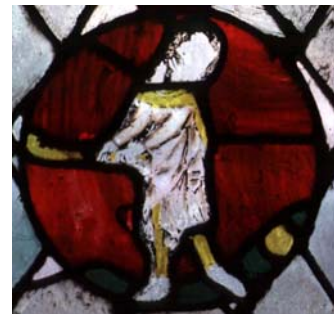
fig. 59 ‘Golfer’ roundel in C11.
What looks like remnants of painted decoration on the head is in fact glazing cement dating from 1976

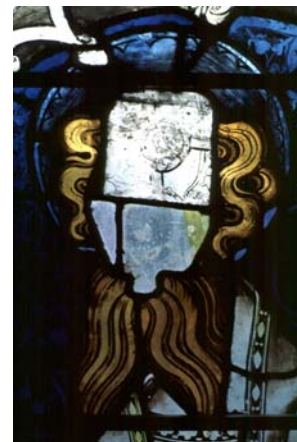
fig. 61 F9
Repair with unrelated
fragments

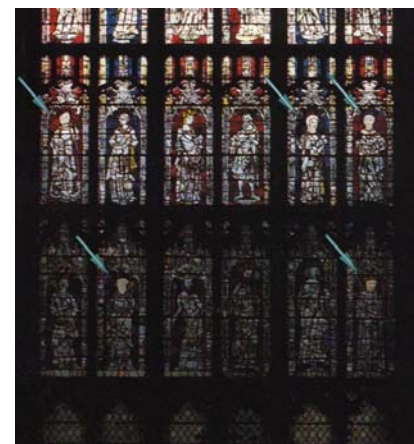
fig. 62 Great East Window, tiers D
and E, lights 5-10.
Effect of indirect lighting on the pink
heads compared with original glass
(D6, D10, E5, E8 and E9 marked with
arrows).

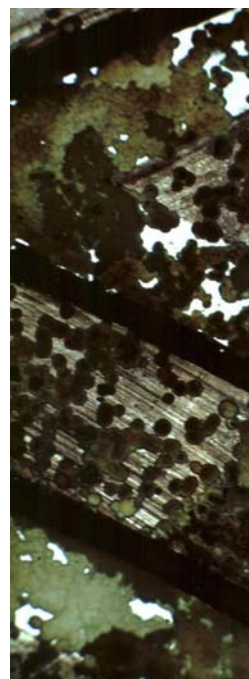
fig. 83 Corrosion of glass aggravated by acidic secretions from micro-organisms. Gloucester Cathedral, Great East Window, panel F1, 2.
