## CHAPTER 1

### Introduction

The aim of this study is to investigate the well-known and widespread problem of severe paint loss from stained glass windows made by many firms in the mid- to late-nineteenth century. This problem results in the fading of painted detail from the surface of the glass, in the worst cases leaving pieces completely blank, as well as ‘ghosting’ of areas where the paint has been lost (Figures 1 and 2). It has become known as the ‘borax problem’,<sup>1</sup> most likely due to a letter sent by William Morris to George Howard, around 1880, in which he writes:

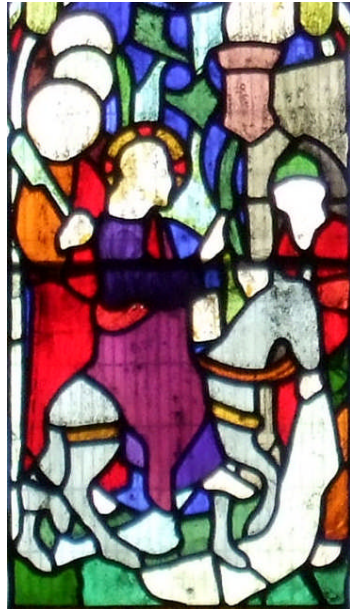
*Figure 1: The entry into Jerusalem  
with blank pieces due to paint loss  
Detail from North aisle window n7,  
Sherborne Abbey*

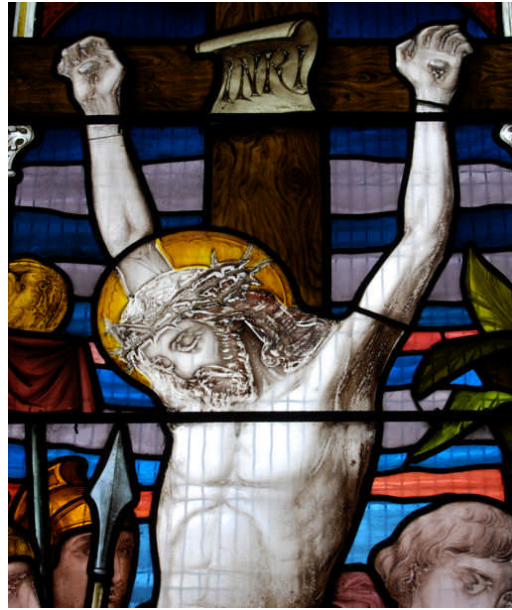
*Figure 2: Head of Christ showing  
'ghosting' due to paint loss  
Detail from East window,  
St Peter's Church, Conisborough*

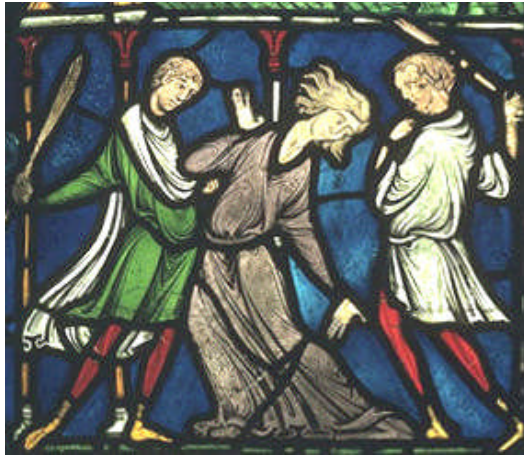
*Figure 3: 'Mosaic' style, using only black paint and coloured glass. Detail from Canterbury Cathedral window n11, ca. 1213-20*

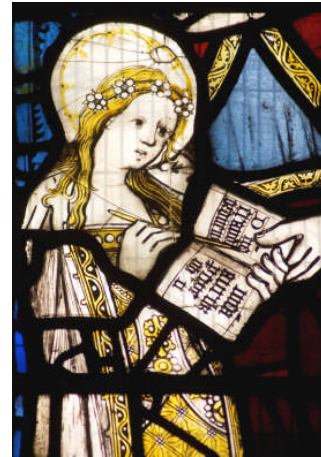
*Figure 4: Painted and stained glass Detail from All Saints' Church, North Street, York, East window, fifteenth century*

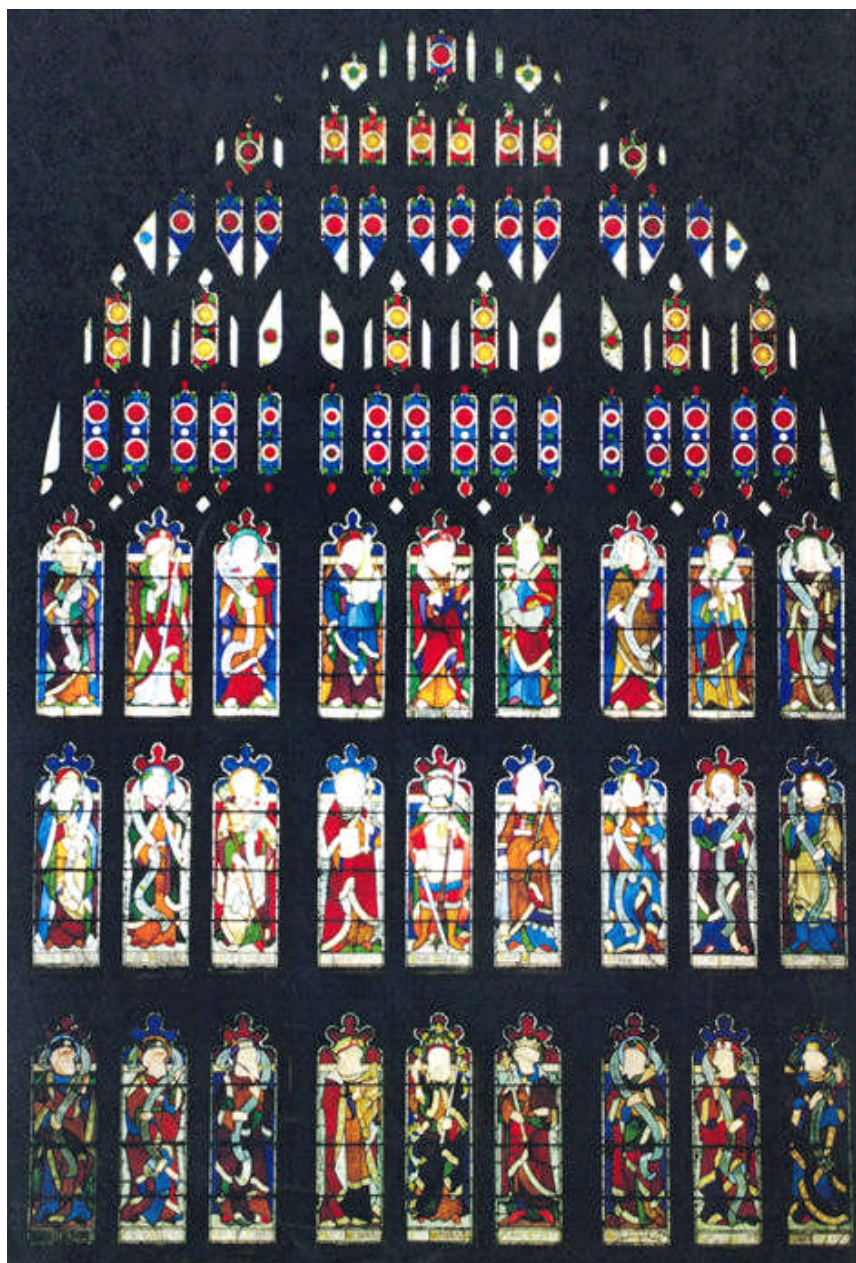
*Figure 15: Sherborne Abbey former West window*

Problems of water penetration and paint loss of the West window were noted in the 1970s by the Abbey architect Kenneth Wiltshire, although no actions were taken at that point.<sup>23</sup> A full survey undertaken by Wiltshire in 1989 noted that the leadwork was in poor condition, and there were “a considerable number” of broken and missing glass pieces, leading to “appreciable water penetration”; in addition, “many of the faces, inscriptions and swags can no longer be read”.

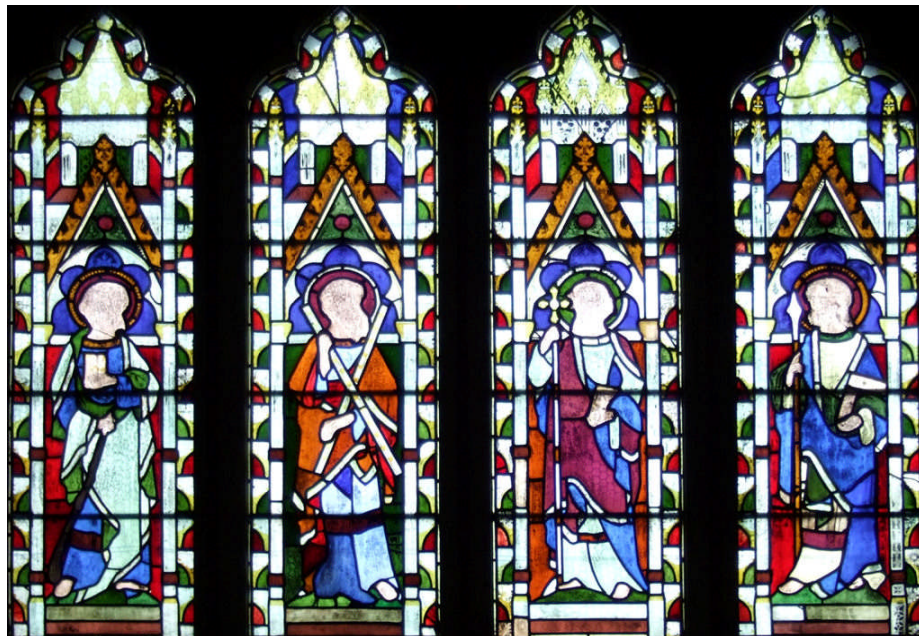
*Figure 17: Sherborne Abbey North Aisle window n9  
showing almost total paint loss*

The "necessary repairs" were made in October 1866, and entered into the Glass Sales Day Book as "Faces, hands and feet of the 12 Apostles restored" [no charge].<sup>34</sup> No indication is made of how the restoration was carried out, but sadly it has proved as impermanent as the original (Figure 17).

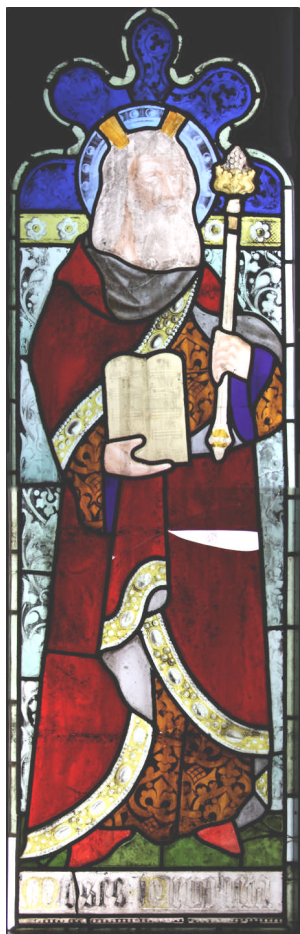
Figure 38: Sherborne Abbey w1 panel 2d  
(Moses)

Overall, the panel is in a rather poor condition, with several cracked or missing pieces of glass, many lead and solder fractures, and much surface dirt. The most severe problem with panel 2d, however, as can be seen from Figure 38, is the loss of painted detail. Very little paint survives on the face, hands and tablet of the commandments, leaving only 'ghosted' images with some flesh-tone shading. Other areas, however, seem to have survived slightly better, such as the pattern on the halo, areas of the diapered background, and some of the drapery (Figures 42 – 44). This suggests that there is some difference between the paints used, or their application, in these different areas. It is noticeable that the best preserved areas throughout the panel are those painted on a deep yellow potmetal glass, used for Moses' undergarment. For some reason, these pieces are all reversed, such that the main painted detail is on the outside face rather than the inside; this reversal, and the better preserved paint on these yellow pieces, are also noticeable in the drapery of panel 2f (Aaron, Figure 40).

Three main light panels, 2d (Moses), 2e (Joshua) and 2f (Aaron), as well as six tracery lights D1 – D6, were made available for examination and analysis during this study (Figures 37 – 41). Outline condition reports were prepared for each of the panels, and these are given in Appendix 2. For the purposes of this study, however, only panel 2d (Moses) will be discussed in detail, as representing the condition of the whole window.

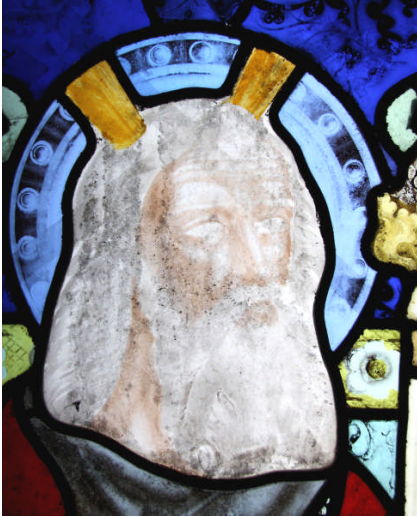
*Figure 42: Detail showing paint lost from face but preserved around halo*

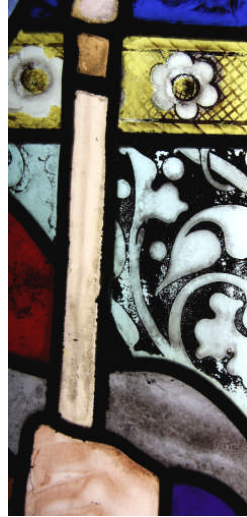
*Figure 43: Detail showing paint lost from hand but preserved on background*

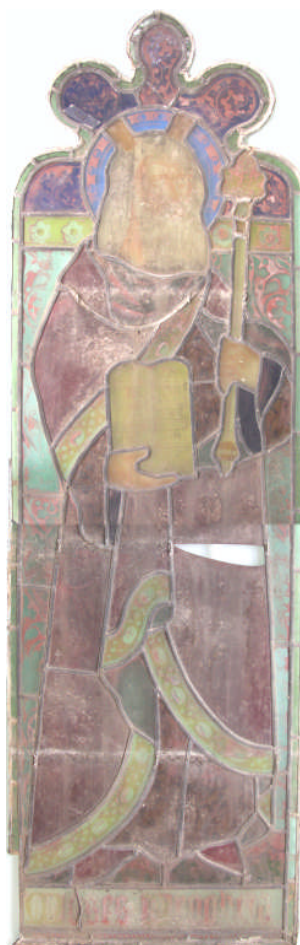
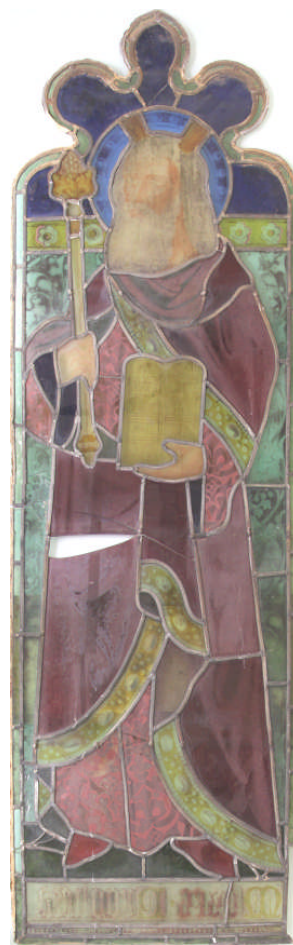
*Figure 45: Sherborne Abbey w1 2d,  
inside face (reflected light)*

*Figure 46: Sherborne Abbey w1 2d,  
reverse face (reflected light)*

When viewed in reflected light, the surviving paint can be seen to be rather reddish brown in colour (Figures 45 and 46). Even those areas on the front face which appear to have survived relatively well show some deterioration, possibly salt efflorescence, of the painted surface (Figure 47). The reverse face shows the extensive use of back-painted shading as well as the detail on the reversed yellow pieces, both of which appear to be in relatively good condition. Interestingly, there is no back-painted shading on the face or hands (presumably due to the use of flesh-tone shading in these areas), which could partly explain why these areas stand out for their paint loss; even though the drapery areas have lost their surface paint, they retain some of their modelling in the back-paint.

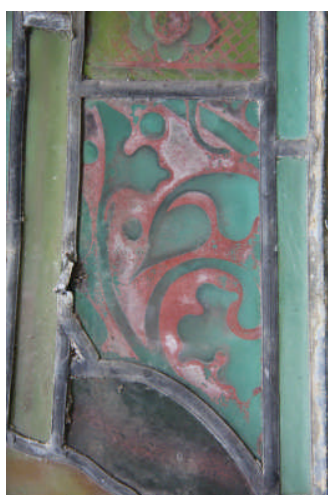
*Figure 47: Detail of  
deteriorated paint on  
inside face (reflected  
light)*

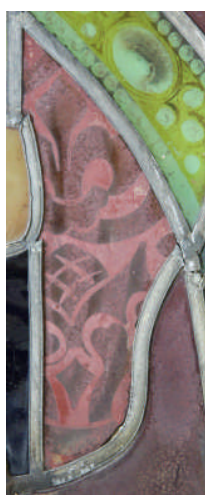
*Figure 48: Detail  
of paint on  
reverse face  
(reflected light)*

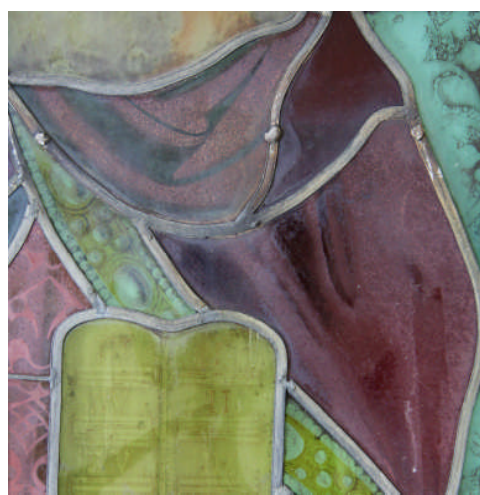
*Figure 49: Detail of shading on  
reverse face (reflected light)*

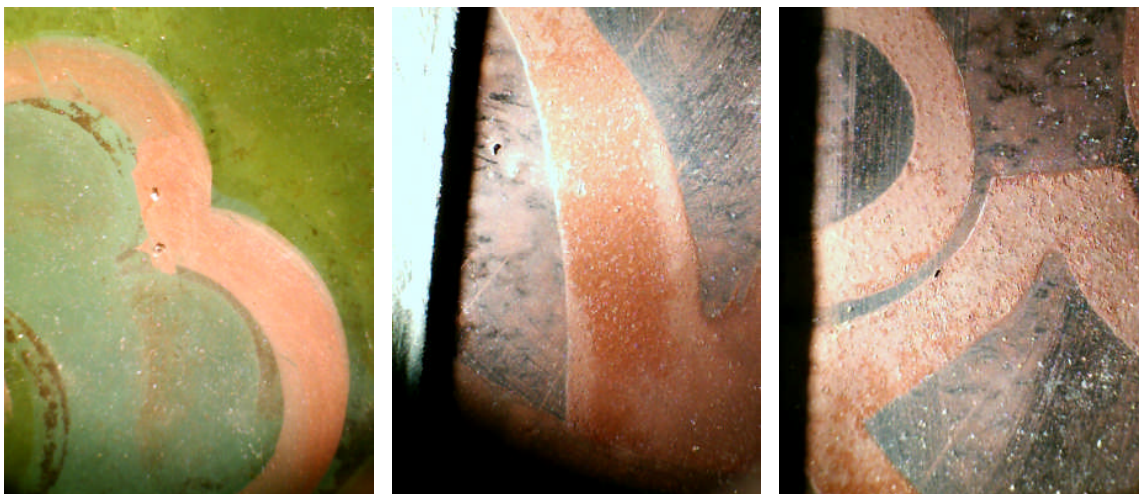
*Figure 51: Paint surfaces on the reverse face viewed under a digital microscope (reflected light)*

The paint surfaces on the reverse face are generally in much better condition than those on the inside face, however, viewed under the digital microscope they can also be seen to contain pinholes in the painted surface (Figure 51). In fact, the paint surfaces on the reverse face appear very similar to the best-surviving of the paint surfaces on the inside face; this might suggest that the same paint and firing conditions were used for both, but that the paint on the reverse face has remained nearer to its original condition, while that on the inside face has deteriorated over time.

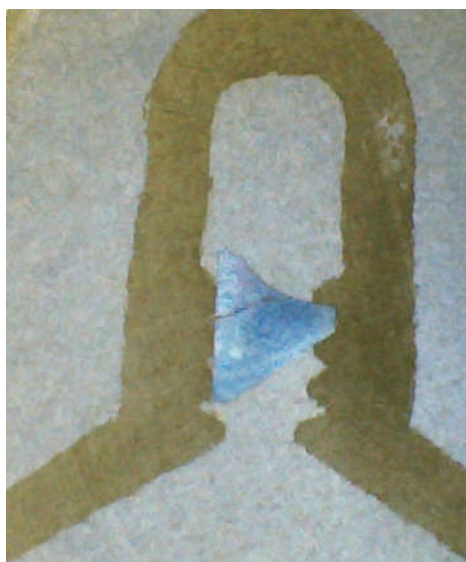
*Figure 53: Sherborne sample 1; note sample held in plastic clip within the embedding resin*

Unfortunately the mounting process caused some of the samples to be damaged; however, most showed at least some of the painted edge (Figures 53 and 54).

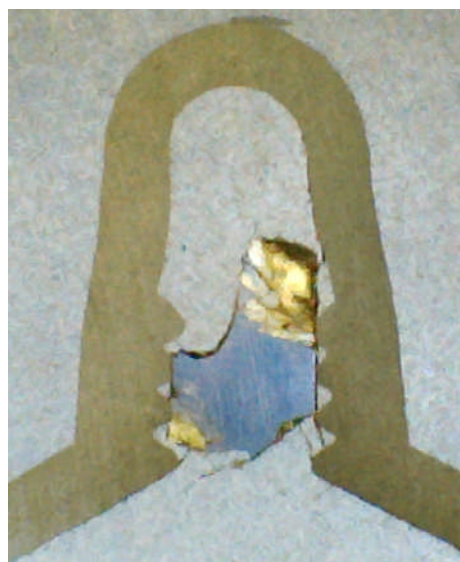
*Figure 54: Sherborne sample 9; sample partly damaged in mounting process*

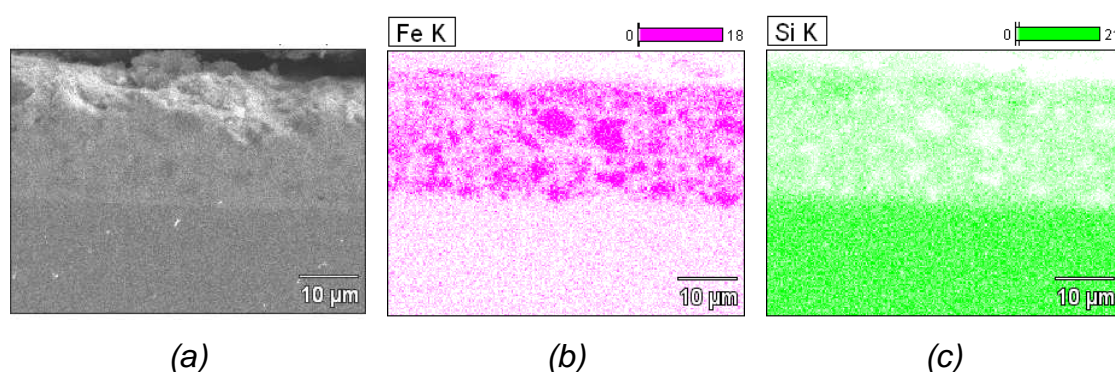
*Figure 61: Element maps of paint layer from Sherborne sample 9  
(a) original image, (b) iron oxide pigment map, (c) silica flux map*

Element maps (Figure 61) show these particles to be composed of iron, in other words, they are the iron oxide pigment particles embedded in the surrounding flux. The size of these particles suggests that the pigment was not very finely ground in production, which is also likely to lead to a rather granular paint layer.

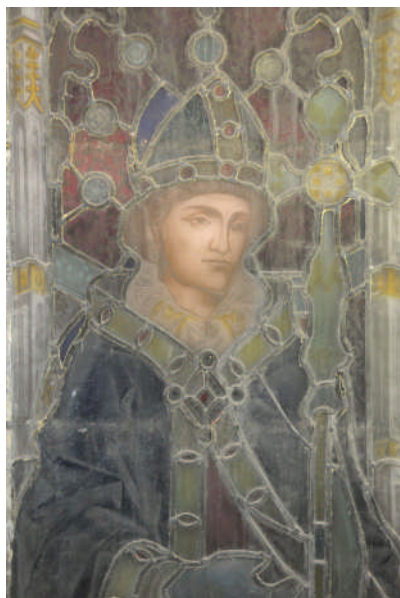
*Figure 65: Beverley Minster w1  
panel 2a in reflected light*

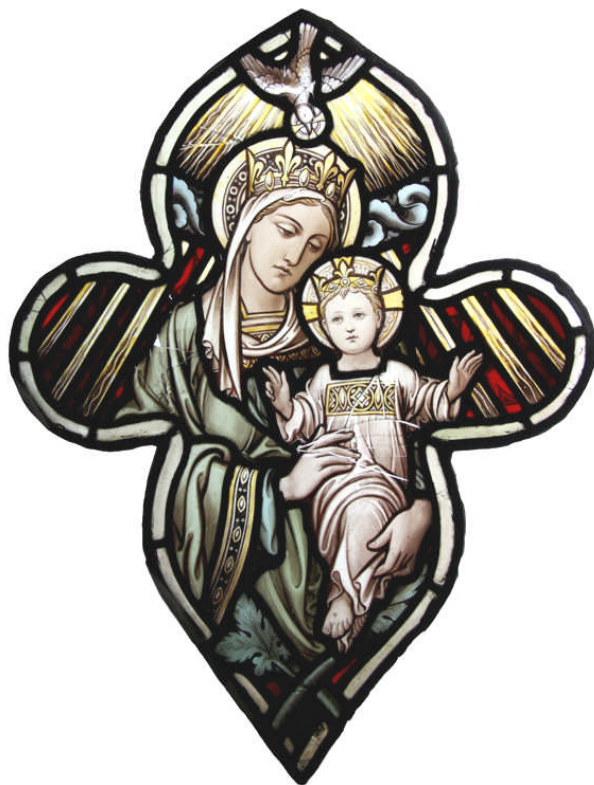
*Figure 73: Virgin and Child quatrefoil from  
All Saints' Church Emscote window n7*

Two panels formerly in All Saints' Church, Emscote, were made available for examination during this study. The Virgin and Child quatrefoil (Figure 73) was the top tracery light of the North Transept 'Jesse' window n7, made by Hardmans in 1889 (Figure 74). The St Aidan quatrefoil (Figure 75) was presumably one of the tracery lights of window n9, which contained standing figures of St Aidan, St Columba and St Ninian; however the provenance of this panel is not clear, as the figures were made at different times, and the tracery is not explicitly mentioned in the Hardman Archive. Condition reports were completed for both panels, and these are included in Appendix 2; further discussion here will be confined to the Virgin and Child panel only.

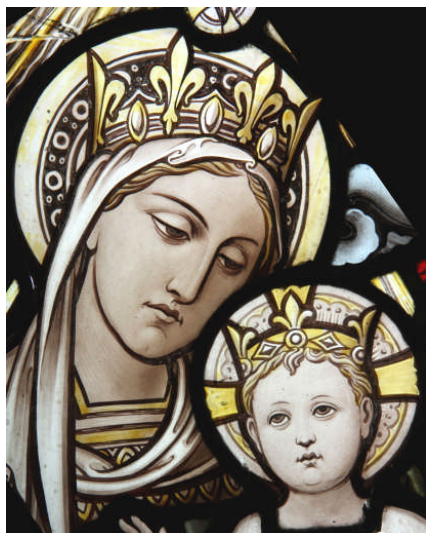
*Figure 76: Detail of Virgin and Child panel*

The Virgin and Child panel is generally in a good condition, although several pieces of glass have suffered physical damage. The leadwork is sound, and the painted detail appears strong and in good condition (Figures 76 and 77).

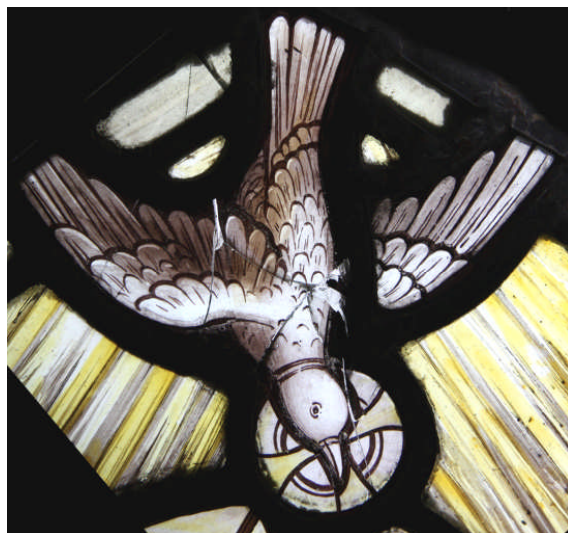
*Figure 77: Detail of Virgin and Child panel*

Viewed in reflected light, the paint appears reddish-brown in colour, with slightly different appearance across the panel, suggesting that some alteration has occurred to the paint surface (Figure 77).

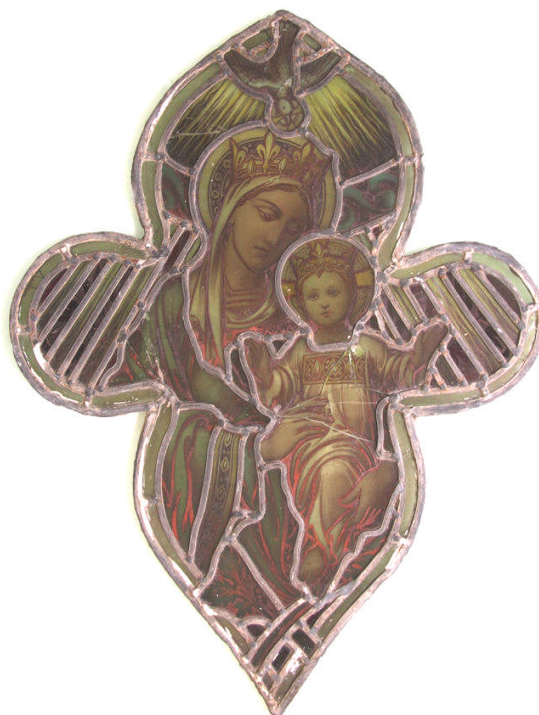
*Figure 78: Virgin and Child panel (reflected light);  
note redder areas in lower part*

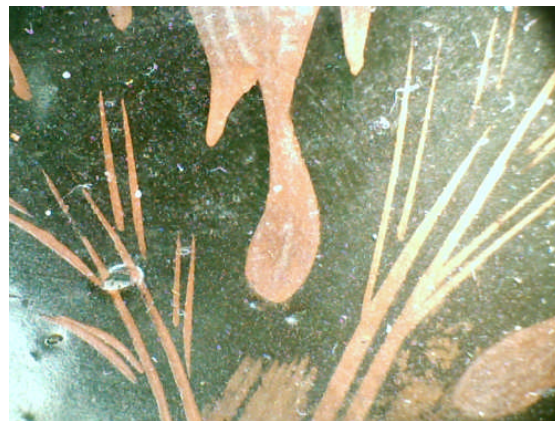
*Figure 81: Detail viewed under digital microscope (reflected light): good paint surface*

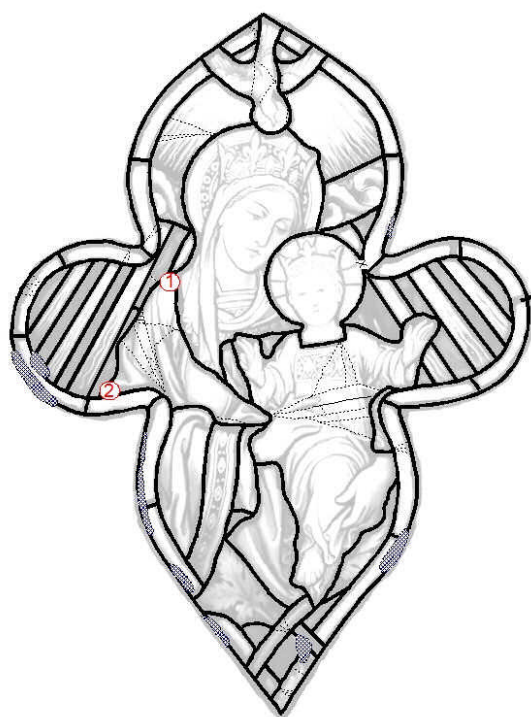
Sample 1 Green tinted glass with  
traceline paint on front face

Sample 2 Green tinted glass with  
traceline paint on front face

*Figure 82: Diagram of Virgin and Child panel; sample locations and descriptions*

In order to further investigate the structure and composition of the paint used, two small samples were taken from the corners of the already broken piece of the Virgin's drapery (Figure 82).
