APPENDIX 2

Condition reports

Object Title: Sherborne Abbey previous West window Panel 2d	
Recorded by: A Gilchrist	Date: 25/06/2010
Location: Kings Manor Workshop University of York	Photographs:

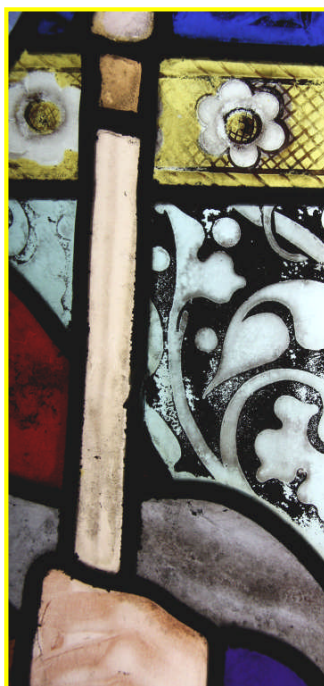
Surviving background detail

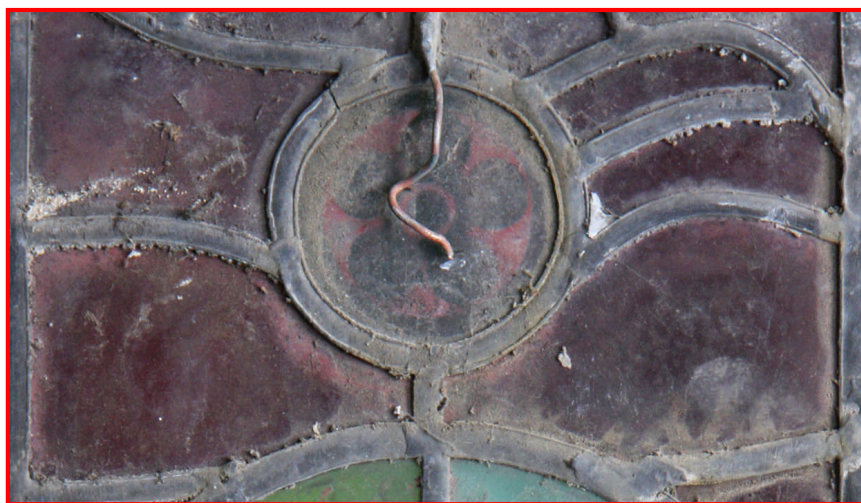
Detailed images (panel D6) – front face, reflected light

Copper tie; surface dirt
