A History of Repairs to the Stained Glass in the Great East Window of Gloucester Cathedral

Léonie Seliger

MA in Conservation Studies (Buildings)
IoAAS

University of York
5 September 2001

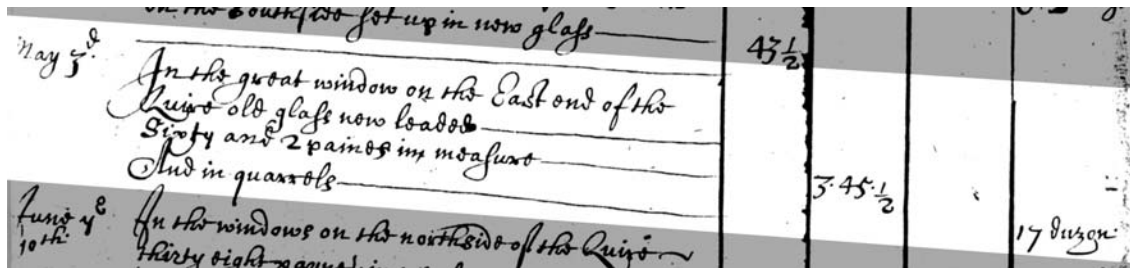
fig. 13 Seventeenth century glaziers' account

The glaziers' accounts for 1660-62 are still in the Cathedral Archives. For 3 May 1661 they contain the following entry: *"In the great window on the East end of the Quire old glass new leaded – Sixty and 2 paines in measure – 345½ feet. And in quarrells – 17 duzon"* (Gloucester Cathedral Library, MS60).

Since the glass of the Great East Window measures some 2000 square feet, it is clear that not the whole of the window was releaded. What the account seems to refer to is rather those panels which were made up from fragments of other windows ('old glass'), or repaired with a substantial amount of such fragments. Other panels may have been transferred from the clerestory whole (Marks 1993, 88), while still other repairs with fragments may have just been stopped in without releading.

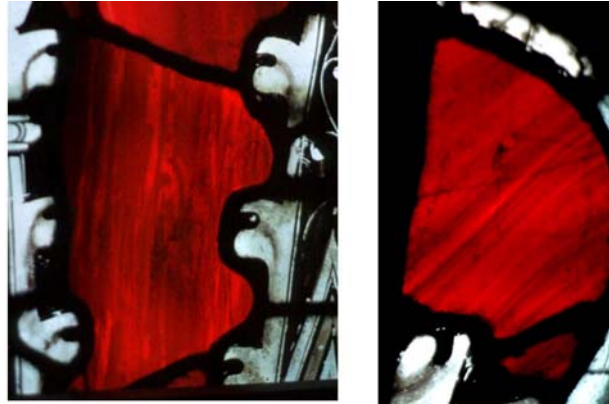
There is a significant amount of blue and red background glass which has been painted with stippled or streaky matts. A very small number of ruby pieces have been etched to resemble the original streaky ruby, a technique which Winston described in a letter to Joseph Bell in 1847 (Brown 1997, 111).

fig. 20 Etched (left) and real (right) streaky ruby glass

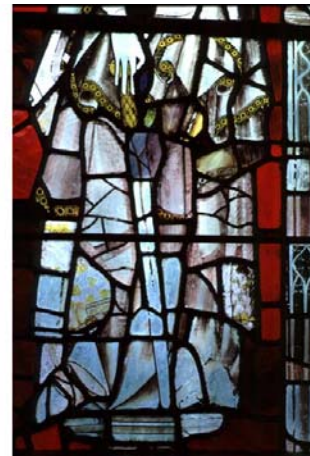
fig. 23 Payne's restoration

drapery and in the architectural border. Payne's treatment was to discard all of those pieces and replace them with new pieces painted in a robust abstract style. On one of them he introduced a different fall of the drapery, a misinterpretation of the original lines which leads me to think that the original pieces were either already lost, or may have been badly damaged in the removal of the panel.

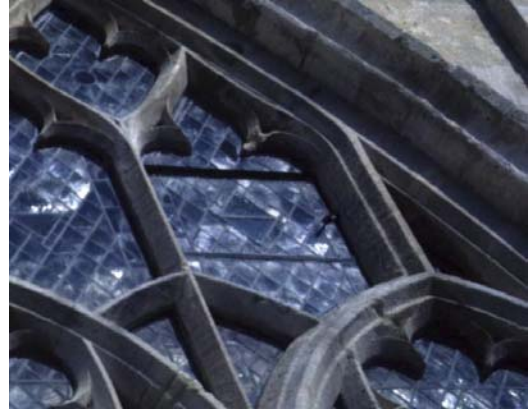
The lack of ventilation in the choir of Gloucester Cathedral adds to the high air humidity levels. Although there are casement windows in the north and south clerestory windows, their opening mechanisms are only accessible from the outside. Opening and closing those casements therefore requires a trip onto the roofs of the choir ambulatory. While this seems to have been a regular task for the cathedral's vergers in the past⁹, today the casements are not even fitted with ropes and are therefore impossible to open without access by ladders.

fig. 32 Casement in south choir clerestory of Gloucester Cathedral

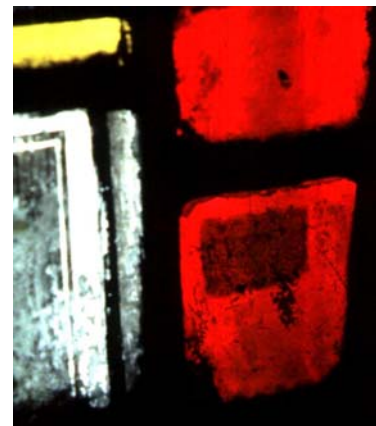
The interior surface of the glass was covered in a layer of accumulated dust and dirt, which over time had formed a grey film. The density of this layer varied, and the smell of the cotton buds used to

fig. 33 Test square left uncleaned on ruby glass.

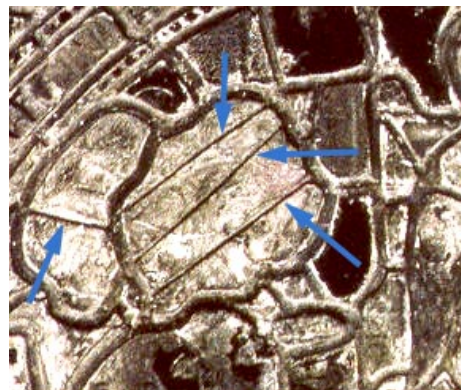
There, thin copper wires had been attached to the lead surrounding broken pieces on the inside, while thin plating glass held the fragments in place on the outside.

fig. 39 Canterbury Cathedral, nXV, 29
Consolidation of broken glass with copper wires

Since plating was not an option for in situ work, we decided to attach the wires to both sides of the panel, and where possible hide them behind trace lines. This technique is very inconspicuous, but holds the fragments firmly in place. There may be a slight possibility of verdigris developing on the copper, which could lead to localised staining of the glass surface. In the Canterbury examples, however, this has not happened.

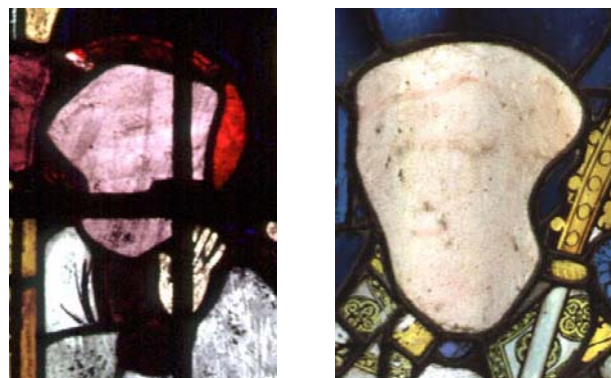
fig. 52 Comparison between pink heads; left: North Moreton, right: Gloucester

used to replace missing heads, arms and legs. All of them are dulled over with a rather reddish paint,

There is no doubt that the seven pink heads in Gloucester are by the same hand as those in North Moreton. We know who was responsible for the insertions in the latter case, so it follows that Ward & Hughes must also be the authors of the seven Gloucester heads.

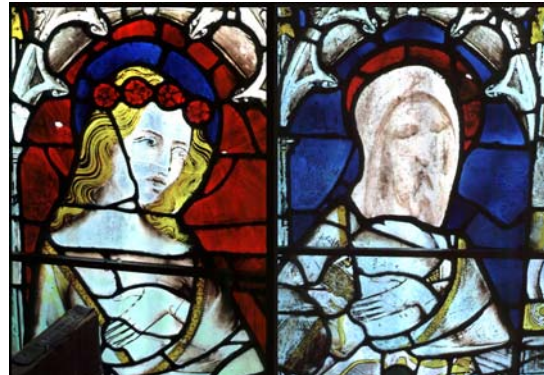
fig. 56 Repeat cartoons

A more subtle use of a repeat cartoon in this window has escaped notice up to now: panel E11, 2 (the upper half of the figure) is, though very fragmentary, still recognisably a variation of E1, 2, a female saint.

The choice of a male head for this panel may have its origin in Winston's attribution of a male sex to this figure whose head he described as 'lost'. But with the bearded head now in place, no writer has since questioned the male identity of this figure.

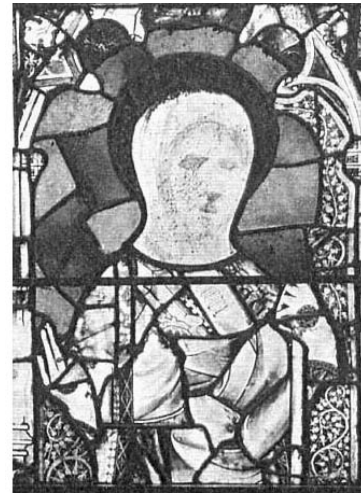
fig. 57 E9, 2

A similar example of gender confusion can be found in E9, where the pink replacement shows a clear indication of a veiled female head. In this case fragments of at least two different original figures, together with unrelated medieval fragments, were used to make up the figure. At least one of the original figures was that of a bishop or abbot, as indicated by the surviving embroidered gloves.

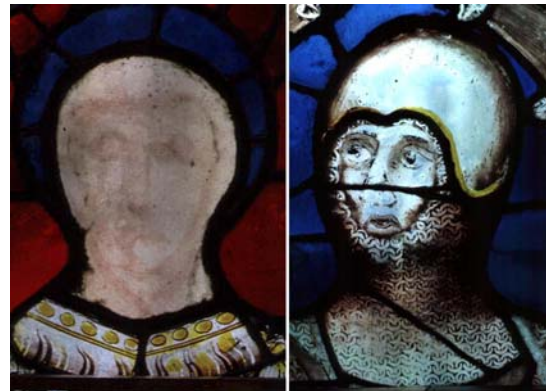
fig. 58 E10

The pink replacement head in E10, however, though with only a very faint suggestion of a face, favours a male aspect. It has a vague similarity with the original head in E2, that of the helmeted St. George.

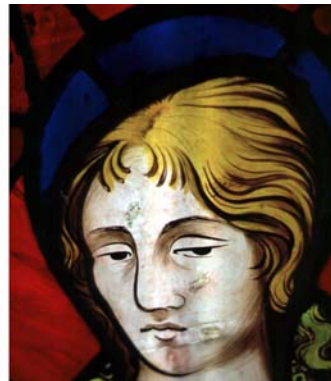
fig. 67 Close-up, showing the interference of paint on the pink face with the new design

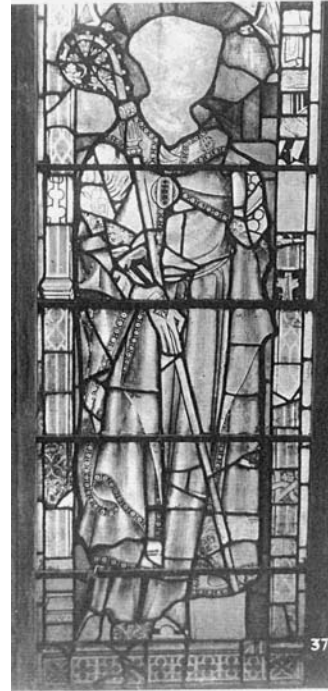
fig. 68 D1

The figure is similar in stance to D3, but not a repeat cartoon. The figure's right arm down to the wrist and the left hand are missing and were replaced with unrelated medieval fragments. Apart from a few other minor stop gaps the drapery is intact.

The ruby background glass surrounding the pink head contains very few replacements. The shape of the head is probably original.

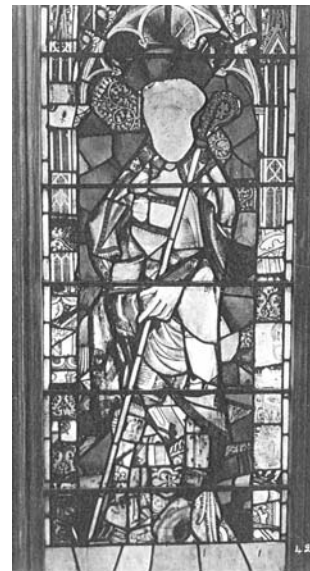
fig. 69 D6

The figure is a conglomerate of fragments, some from the Great East Window or maybe from the clerestory glazing, others from other glass of a later date.

The blue background glass, which in this lancet should be painted with a pattern of swirling leaves, consists mainly of unpainted medieval glass. Only four painted pieces survive.

The shape of the pink head, though consistent with the shape of the other surviving abbots' heads, may not be original.

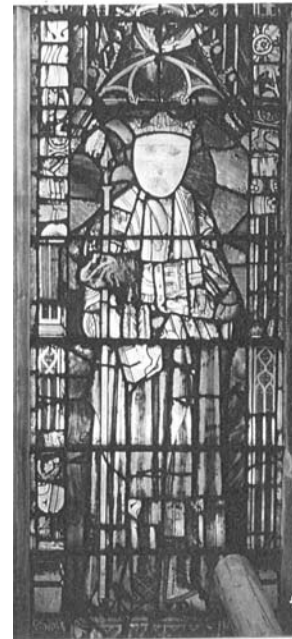
fig. 70 D10

The lower half of the figure is a repeat cartoon of D12.

The upper half of the figure, including the background glass, consists entirely of fragments of later glass. Only the hand in this panel may originate from the Great East Window. The iconography of this panel, a crowned figure holding a spear, is a complete invention. The shape of the pink head bears no resemblance to any other head in the window.

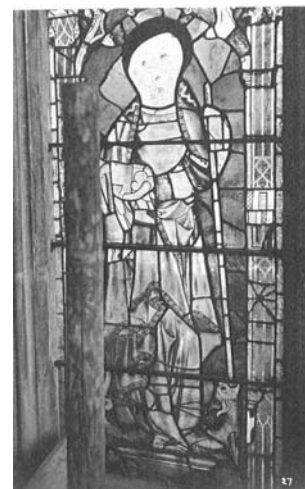
fig. 71 E5

The drapery of the figure has a few stopgaps, but is largely original. There are remnants of the saint's hair on her shoulders.

The background surrounding the top half of the figure consists largely of flashed ruby glass painted with a streaky matt, and is therefore very likely by Ward & Hughes. The ruby glass immediately around the head, however, is largely original.

The shape of the pink head is consistent with that of other female saints in this tier and is probably original.

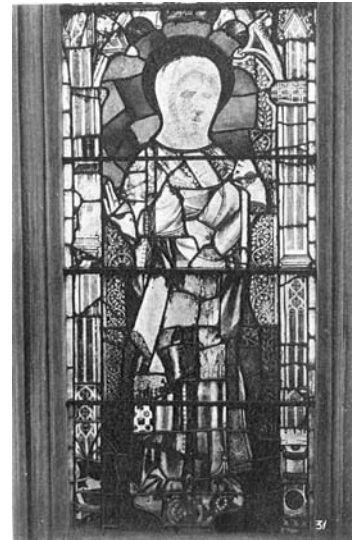
fig. 72 E9

The blue background glass surrounding the head is painted with a stippled matt and is therefore very likely by Ward & Hughes.

The shape of the pink head is unlike that of any other figure in this window (except that of E10, also a pink head, and E2, a helmeted knight) and is unlikely to be original. It is painted with hazy suggestion of a veiled female head.

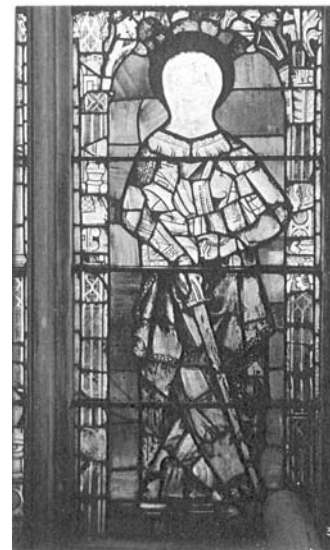
fig. 73 E10

The upper half is entirely made up from fragments of later glass. The ruby background glass consists largely of flashed ruby painted with a streaky matt and is very likely by Ward & Hughes. Only a small portion of original ruby survives at the top of the figure. The halo is also not original.

The shape of the pink replacement head is unlikely to be original.

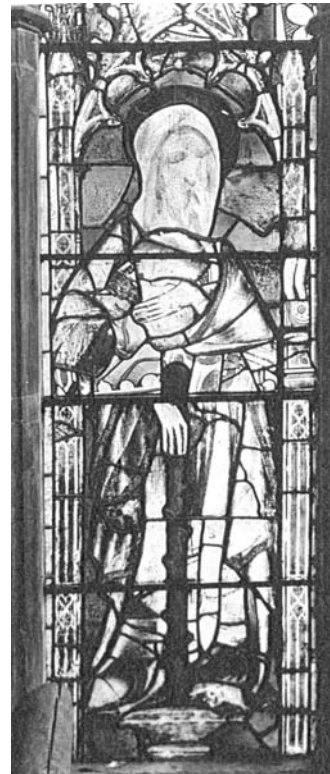
fig. 74 E11

The background glass around this half of the figure consists entirely of original glass.

The shape of the pink head is consistent with the shape of other female saints' heads in this tier. It is also entirely surrounded by original glass. The shape of the head is therefore very likely original. It is painted with the hazy suggestion of a hooded and bearded face.

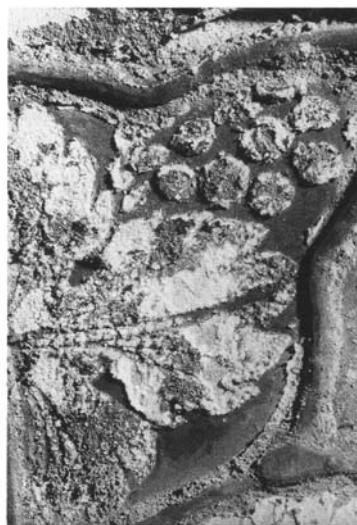
In the past, sulphur dioxide in the shape of air pollution has been accused of corroding glass. In fact, sulphur dioxide does not in itself attack glass, but takes part in the formation of weathering crusts on the corroded glass surface. These crusts contain carbonates and sulphates (gypsum, syngenite, calcite) and are often hygroscopic.

fig. 82 Weathering crust on the interior of a window from Erfurt. The well-preserved dark paint layer is beginning to fail along the edges.

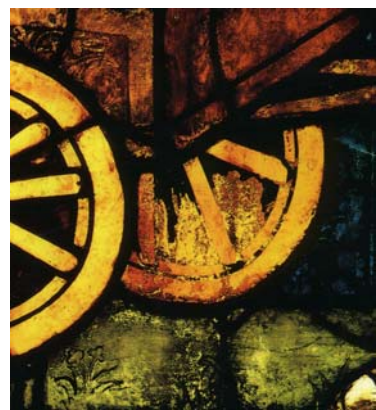
Insufficient firing means that the glass powder did not fuse perfectly with the substrate. Some particles of the paint may not have fused together properly, leaving a porous structure whose non-vitreous components may corrode or be washed away. This type of paint can also promote corrosion of the

fig. 84 Paint loss between the spokes of a cart wheel on a window from Erfurt.

substrate directly beneath, because the paint retains water.
