APPENDIX 2

Condition reports

Object Title: Sherborne Abbey previous West window Panel 2d	
Recorded by: A Gilchrist	Date: 25/06/2010
Location: Kings Manor Workshop University of York	Photographs:

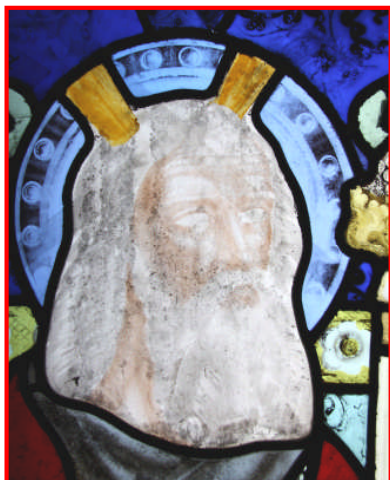
Almost total paint loss from face

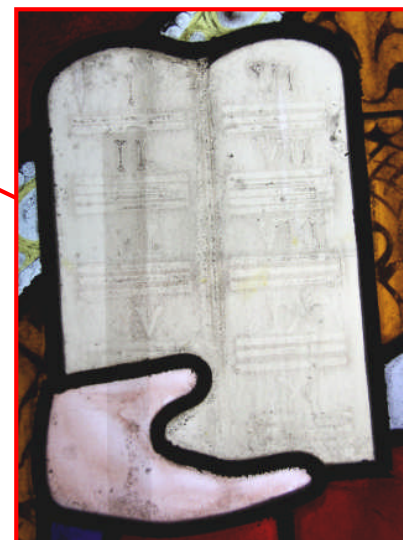
Almost total loss of painted detail on hand and tablets

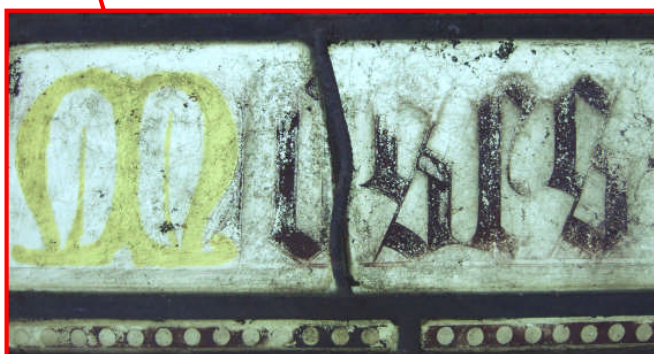
Variable loss of paint on inscription; break covered by strap lead

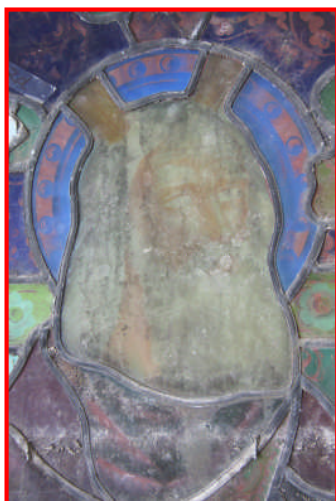
Paint loss from face

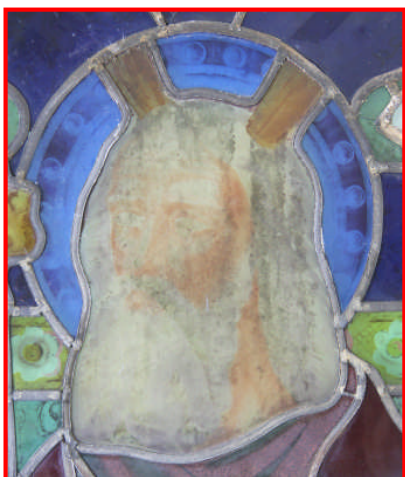
'Carnation' flesh-tone on reverse of face

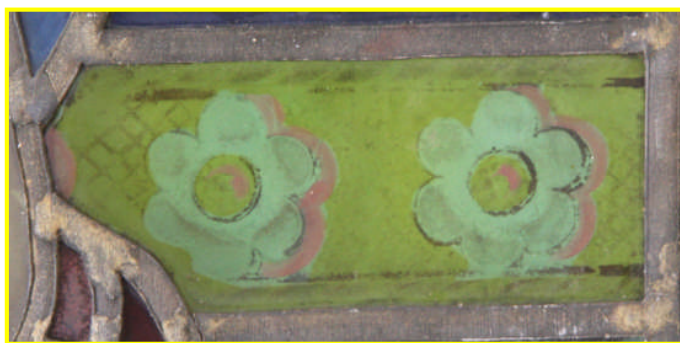
Back-painting in good condition

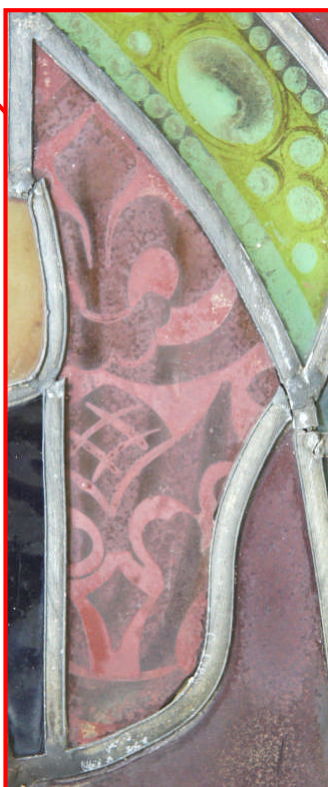
Paint on reverse in good condition

Fractured solder joints

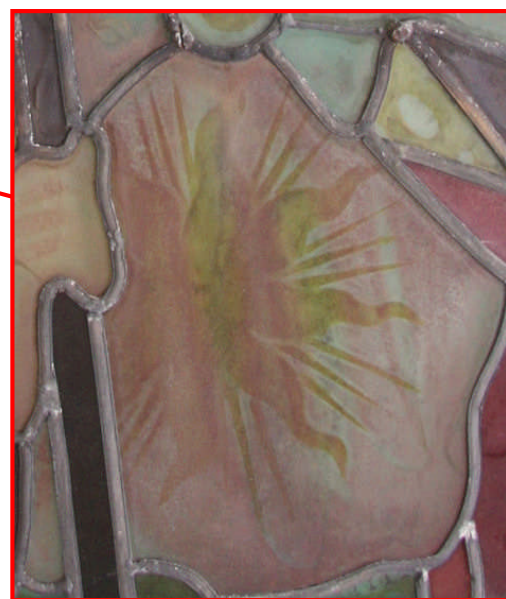
Surviving back-painting

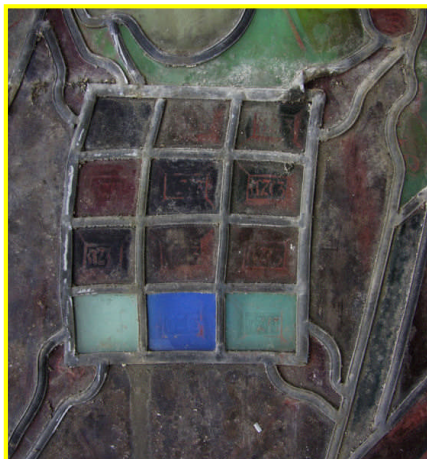
Paint loss, surface dirt

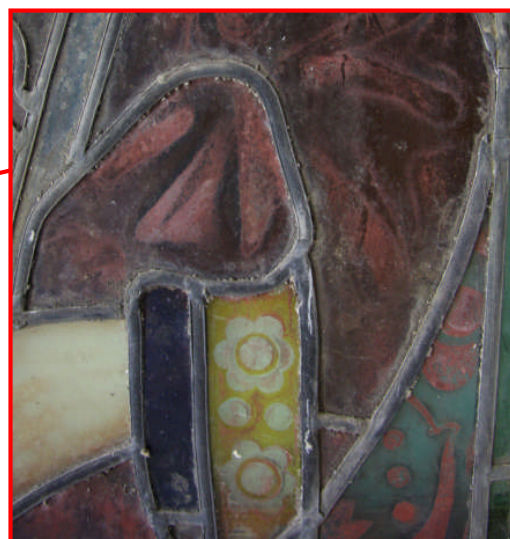
Variable paint loss; survival of modelling

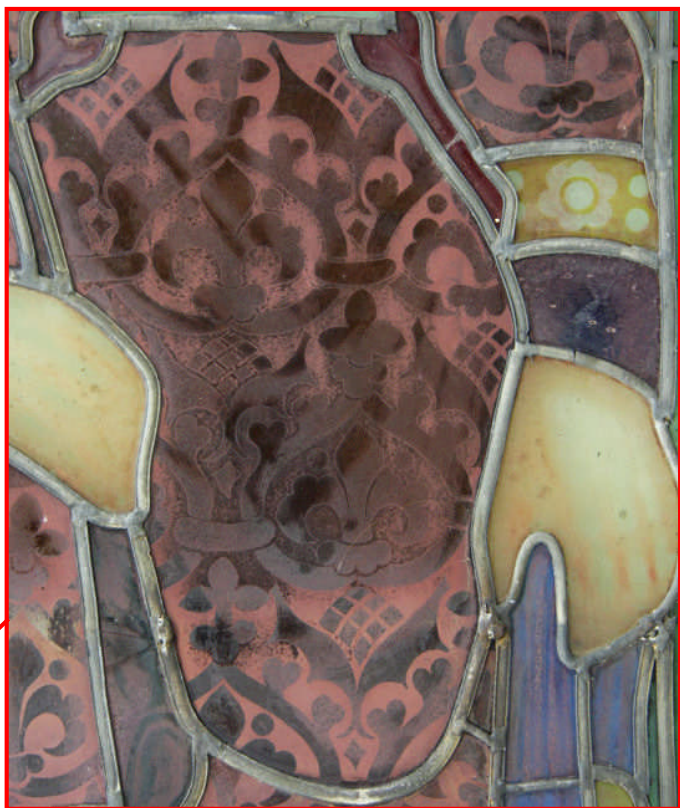
Surviving detail paint on reverse face

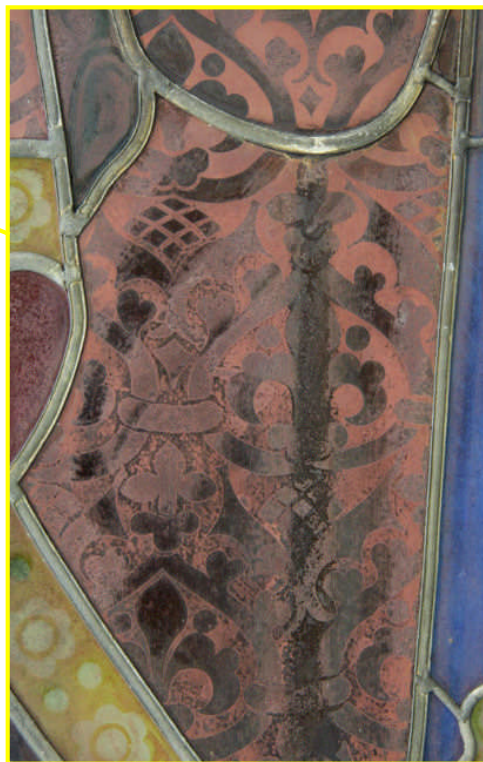
Surviving detail paint on reverse face

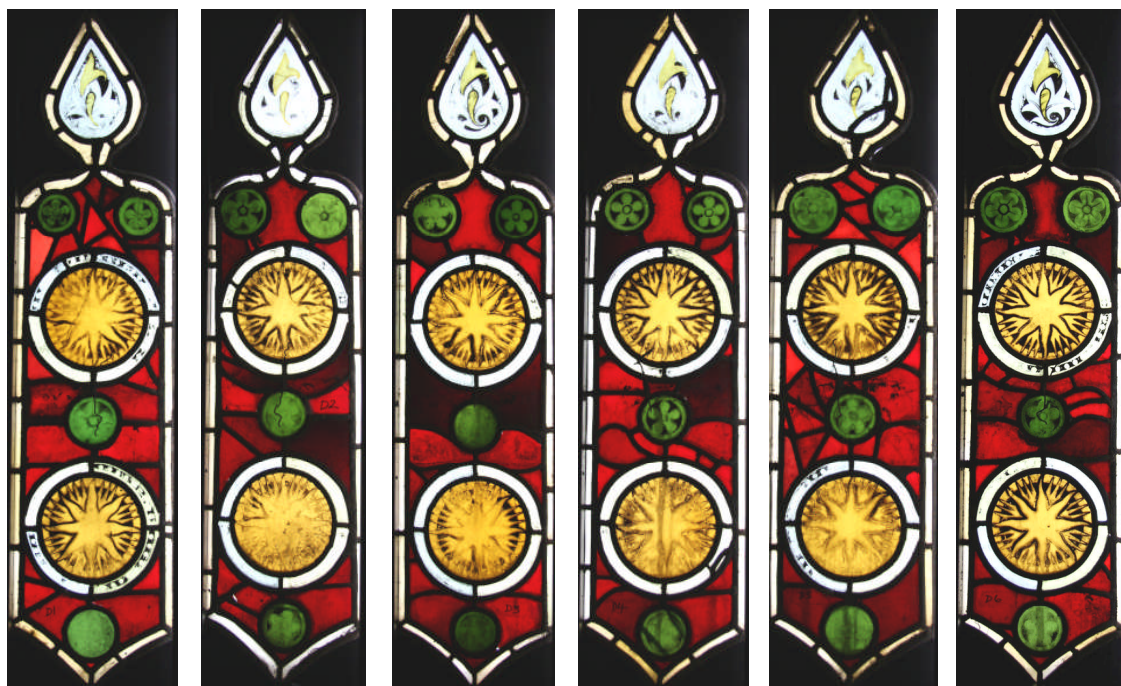
Images – transmitted light

6 mm flat and 4 mm round internal leads; 10 mm flat perimeter lead. Generally good condition. Several fractured solder joints; several missed solder joints, especially on external face.

One stopgap insertion (panel D2); several cracks stopped with black putty.

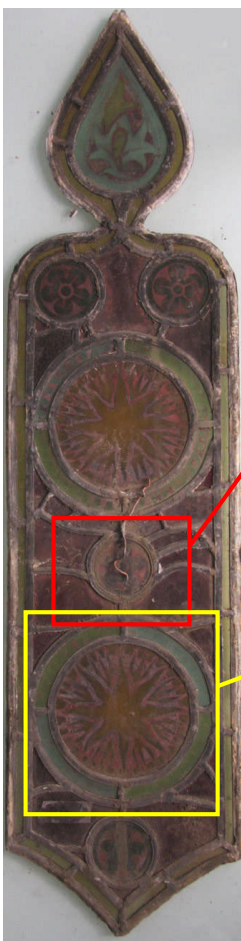
Detailed images (panel D6) – front face, reflected light

Copper tie; surface dirt

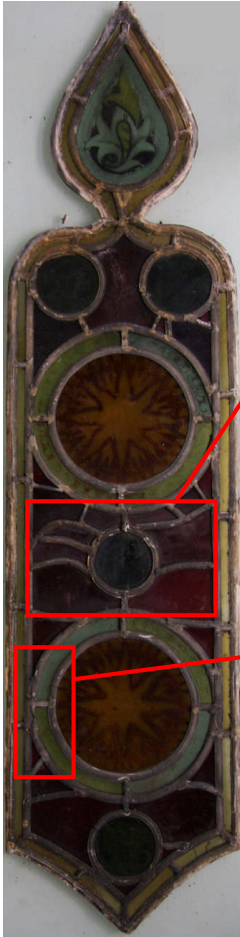
Detailed images (panel D6) – reverse face, reflected light

Surviving paint / patina on reverse face

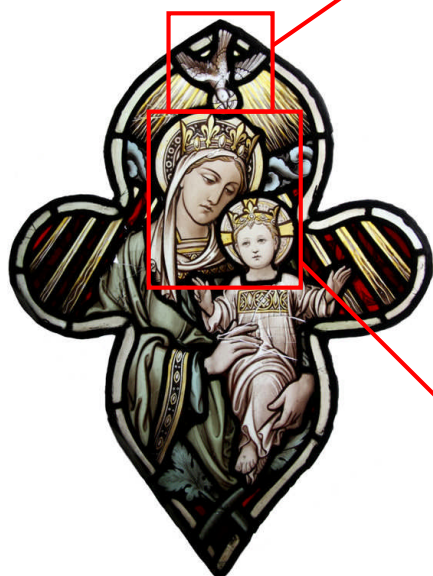
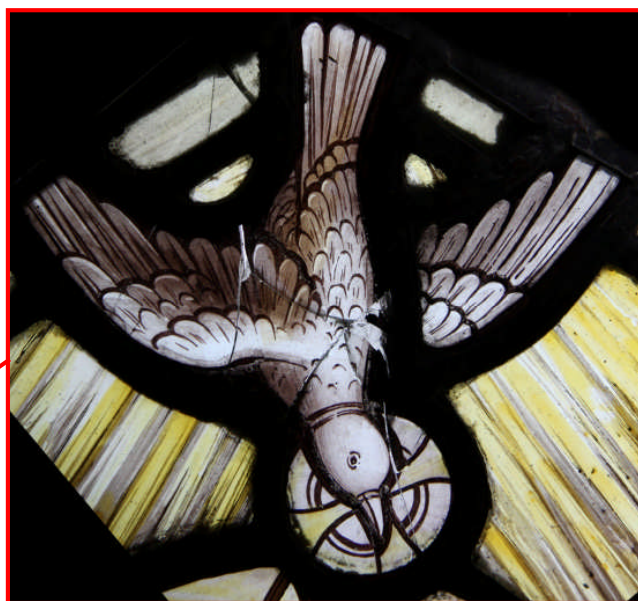
Detailed images – transmitted light

Well-preserved paint detail; breaks in glass

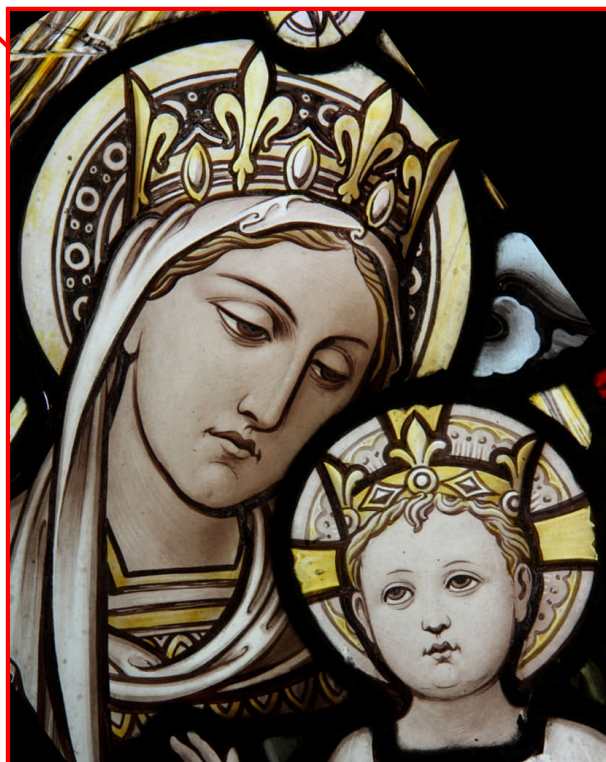
Well-preserved paint detail

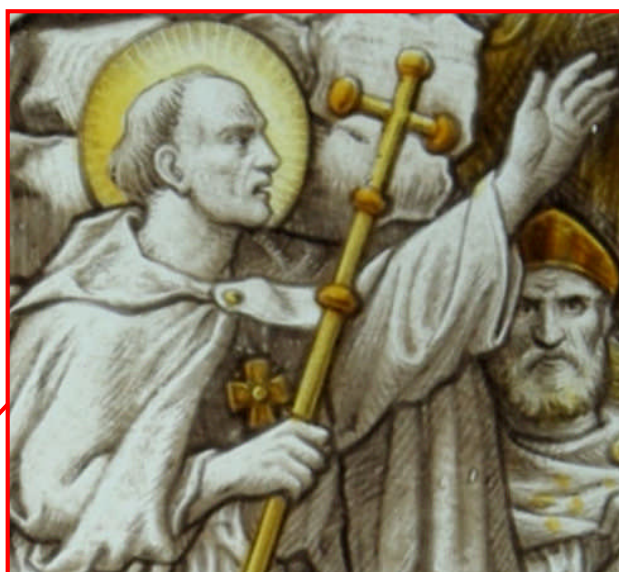
Detailed images – transmitted light

Well-preserved paint; highly detailed painting style
